Your Inspection Report

104 Booth Ave
Toronto, ON

RE: Report No. 9817
104 Booth Ave
Toronto, ON

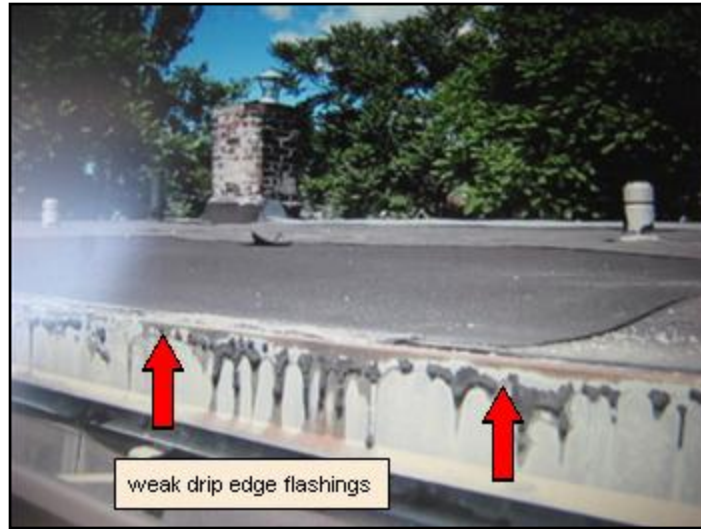
flat roof section

Condition: • Patched

Condition: • Seams open or susceptible to leaks

Task: Monitor/Repair

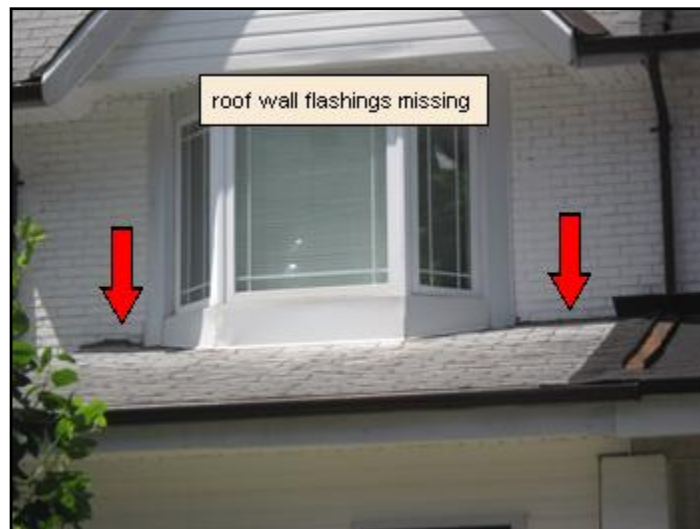
porch

Condition: • [Missing](#)

Time: Immediate

Cost: Minor

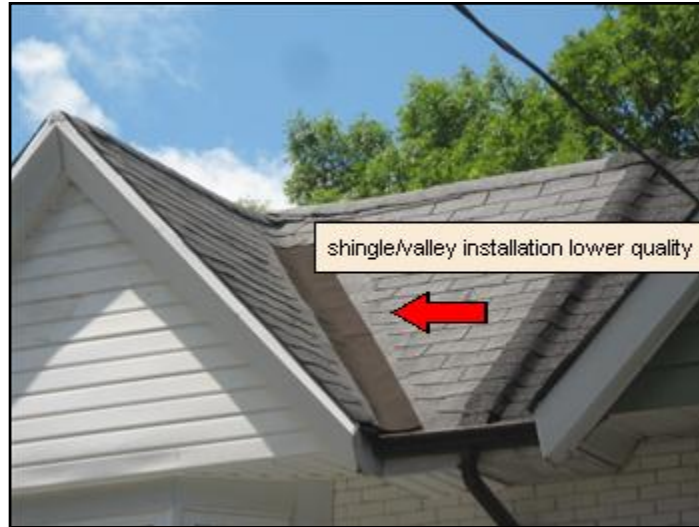
front sloped roof

Condition: • [Suspect](#)

If leak occurs, valley flashings should be replaced.

Task: Monitor/Replace

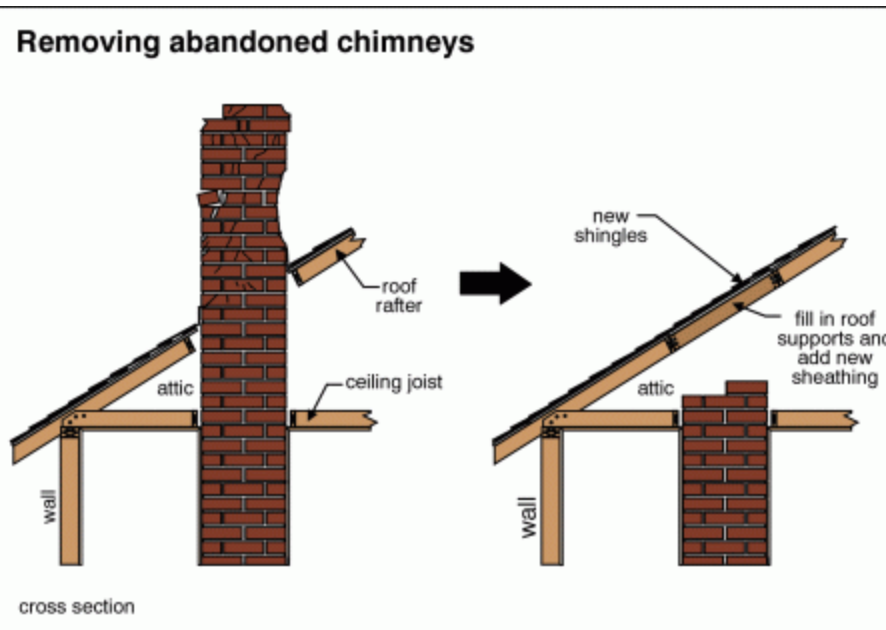
Condition: • [Abandoned - vulnerable area for roof leak](#)

Time: Discretionary

Cost: Minor

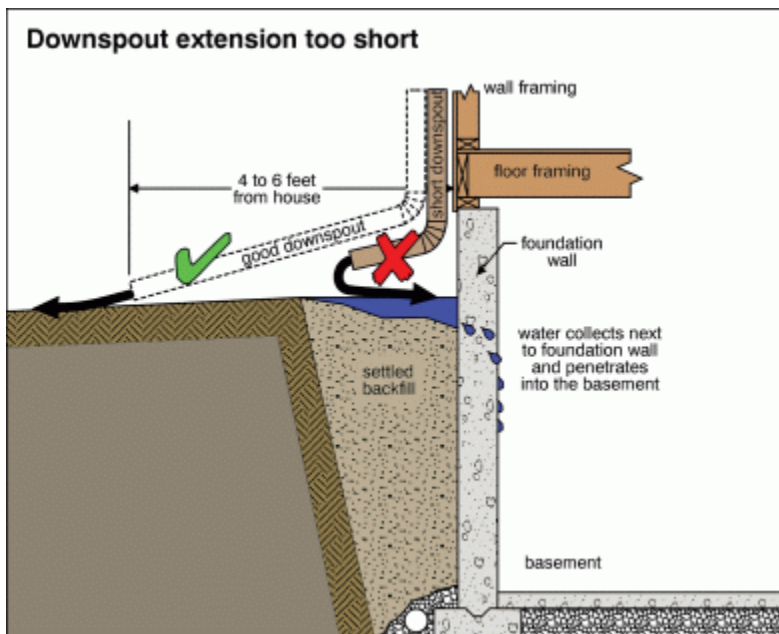
Condition: • [Downspout ends too close to home. It should direct water at least 6 feet from building.](#)

Time: Less than 1 year

Cost: Minor

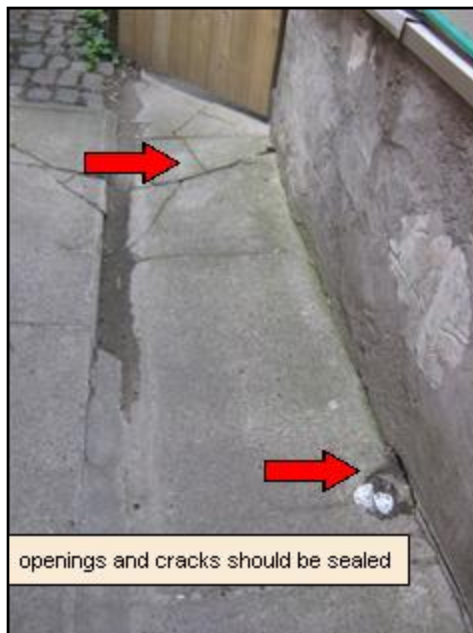
side walkway

Condition: • [Broken up](#)

Time: Less than 1 year

Cost: Minor

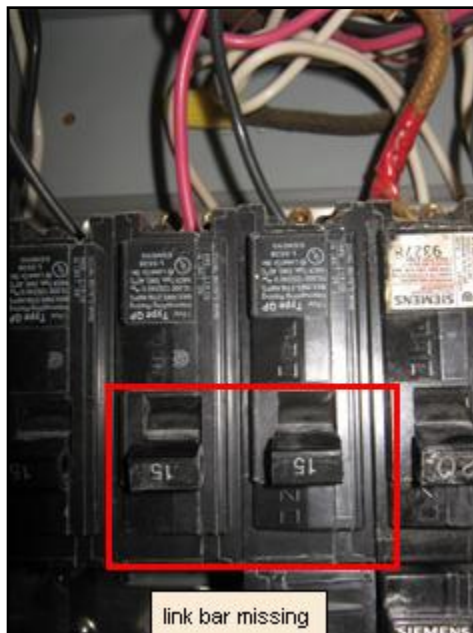
main panel

Condition: • [Link missing on multiwire circuit](#)

Task: Provide

Cost: Minor

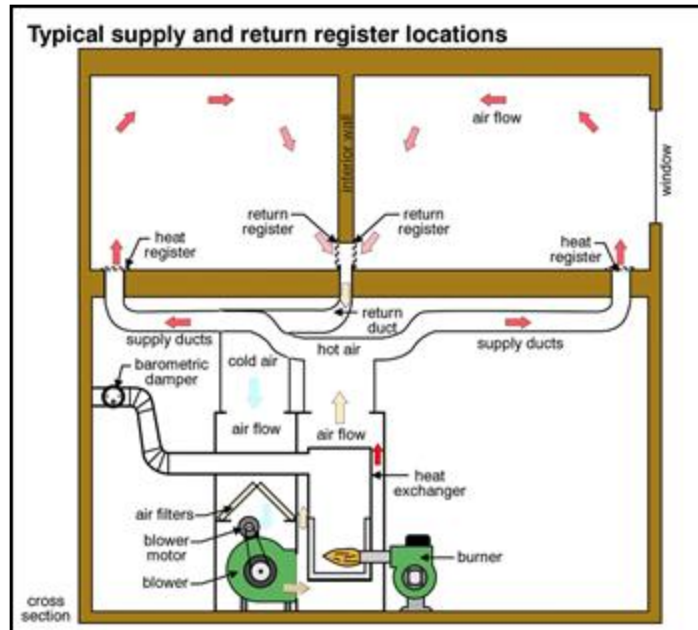
Condition: • [Ducts - layout typical of older house; it may be possible to adjust airflow to provide more even heating/cooling. Improve layout if necessary; consult HVAC specialist for further evaluation if needed.](#)

Time: If necessary

Cost: Depends on approach

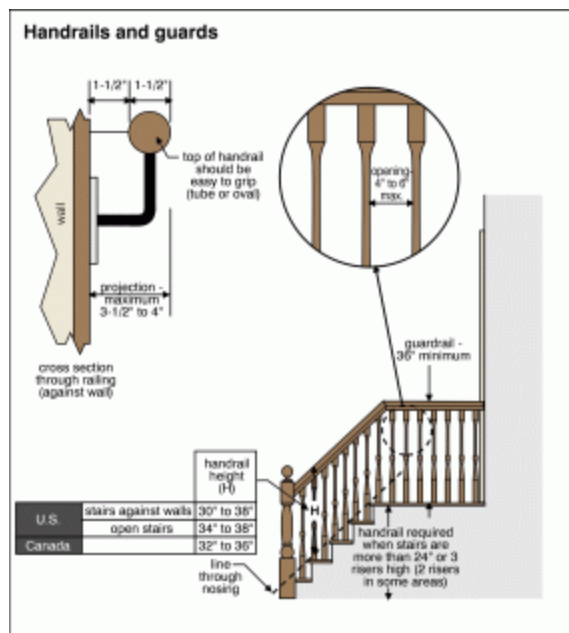
Condition: • [Railing missing](#)

Time: Immediate

Cost: Minor
