# Your Inspection Report

108 Lillington Ave  
Toronto, ON M1N 3K7

RE: Report No. 9992, v.3  
108 Lillington Ave  
Toronto, ON  
M1N 3K7

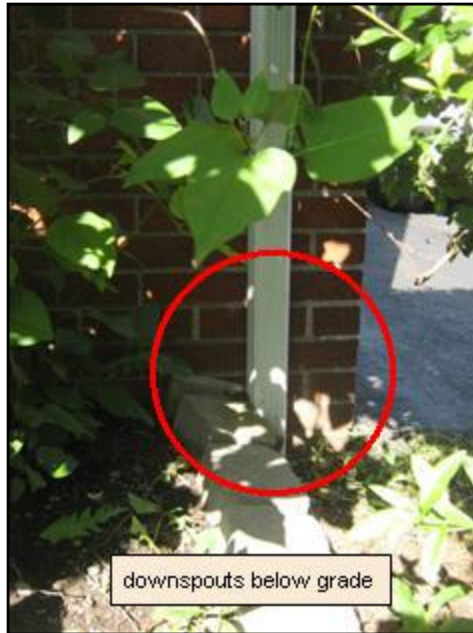
various

**Condition:** • [Discharge below grade is suspect. Redirect to discharge above grade at least 6 feet from building.](#)

While the current arrangement is convenient and a good method to deal with rain water, if the drain pipe becomes clogged and/or deteriorated, there is a greater risk of water backing up and leaking into the basement.

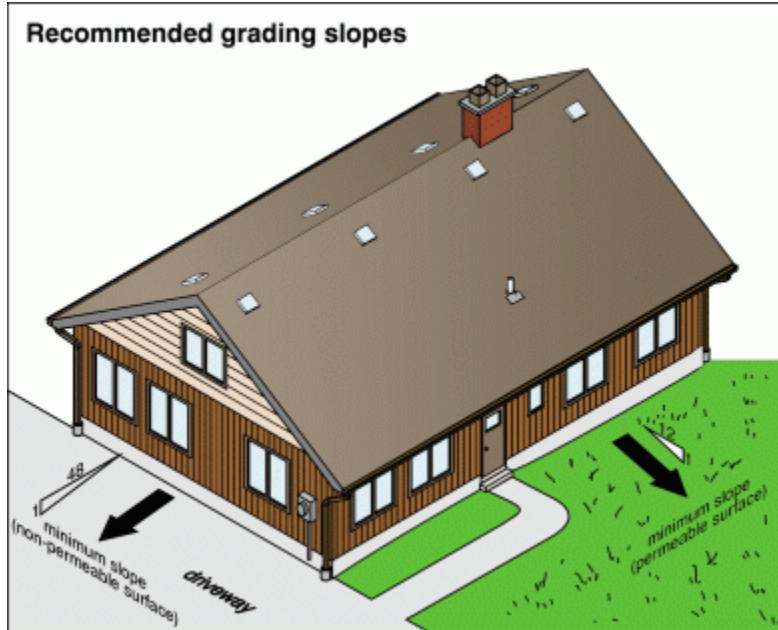
Condition: • [Grading directs water toward house](#)

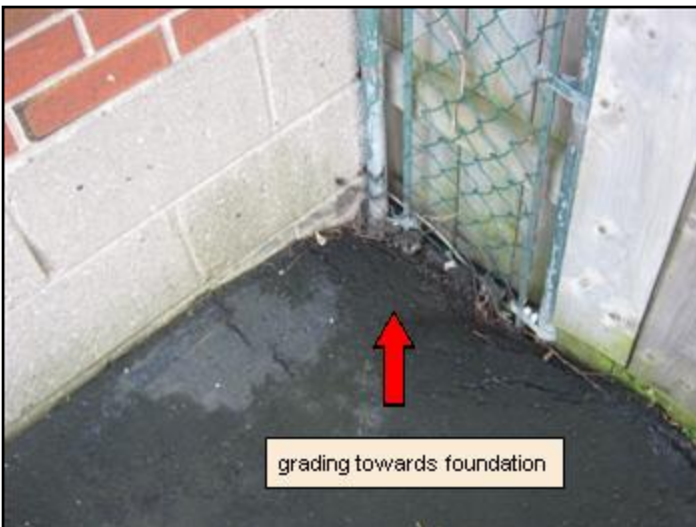
northwest corner

Condition: • [Low areas](#)

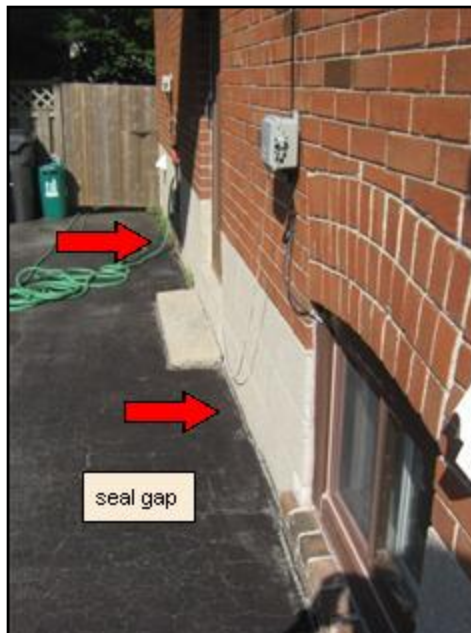
*side walls*

**Condition:** • [Seal gap at house](#)

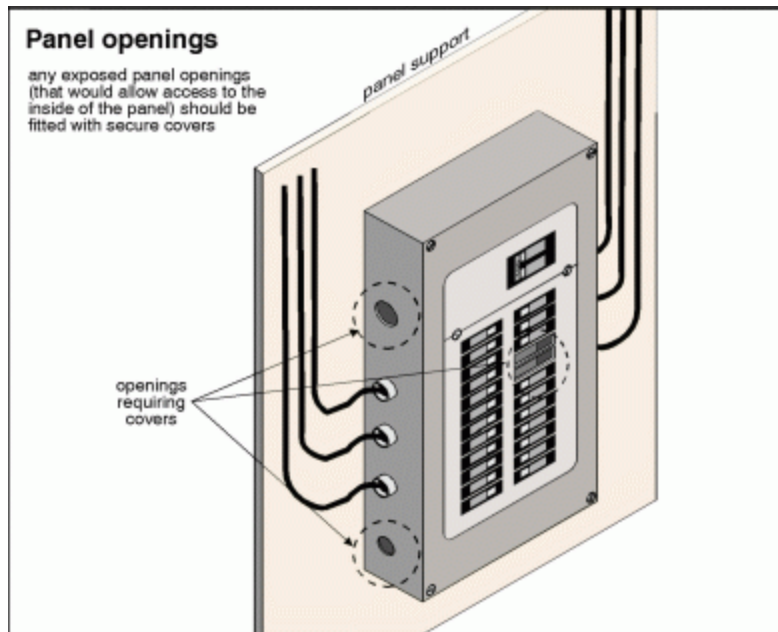
**Condition:** • [Unprotected openings](#)

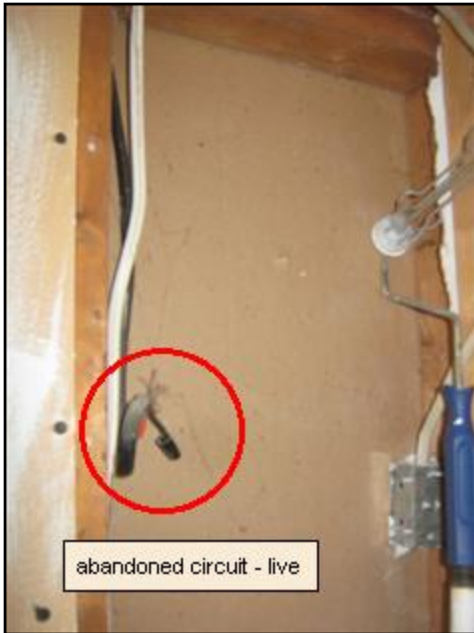
*furnace room*

**Condition:** • [Abandoned](#)

**Condition:** • [Not well secured](#)

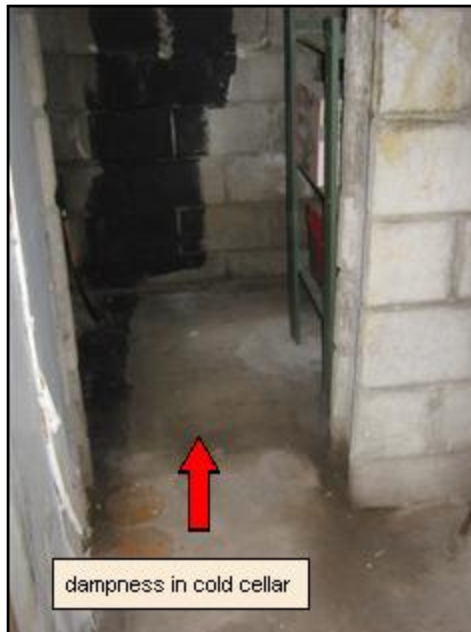
*cold room under front stairs*

**Condition:** • Evidence of basement leakage was noted.
