Your Inspection Report

11 Sandford Ave
Toronto, ON

INSPECTION DATE:
Thursday, April 1, 2010

RE: Report No. 9162, v.2
11 Sandford Ave
Toronto, ON

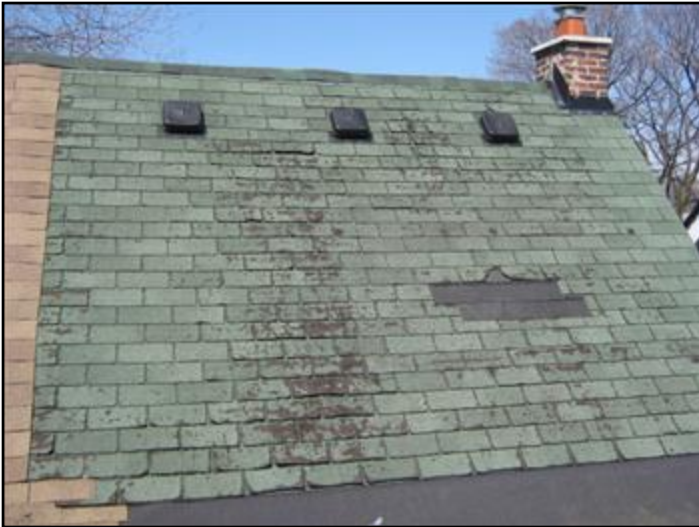
- Past normal lifespan - The roof covering is beyond its life expectancy rear sloped roof
- New - The roof covering appears to be new front sloped roof

Condition: • Near end of normal life expectancy

Task: Replace

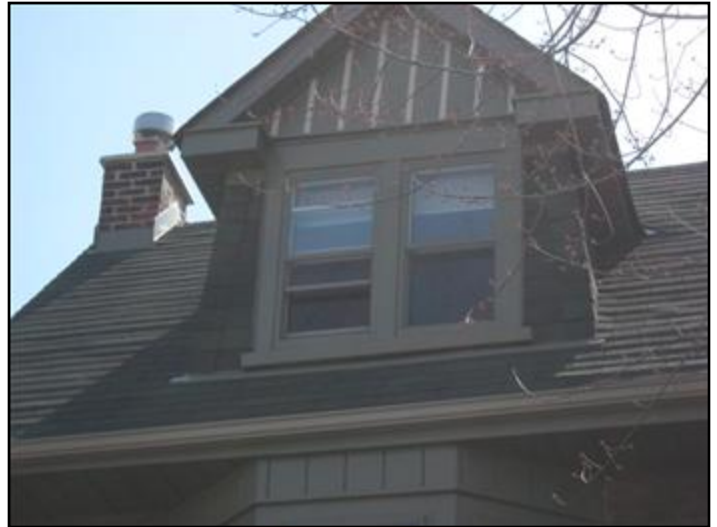
front sloped

General: • The roof is newer and in good condition.

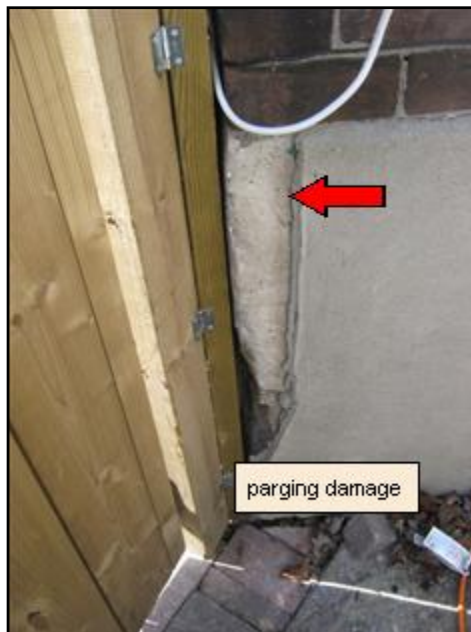
rear corner

Condition: • [Parging deteriorated](#)

Task: Repair

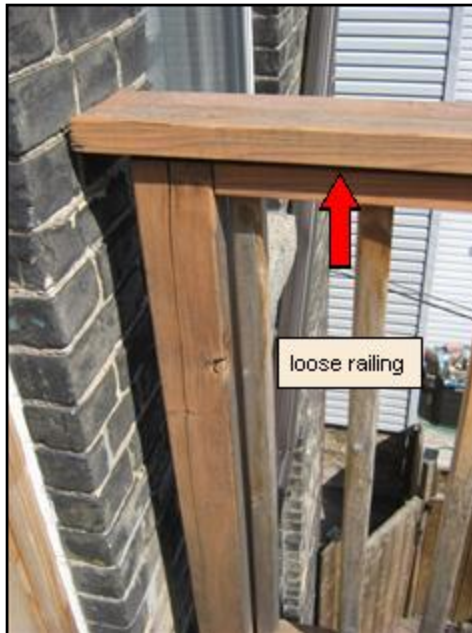
balcony

Condition: • [Loose](#)

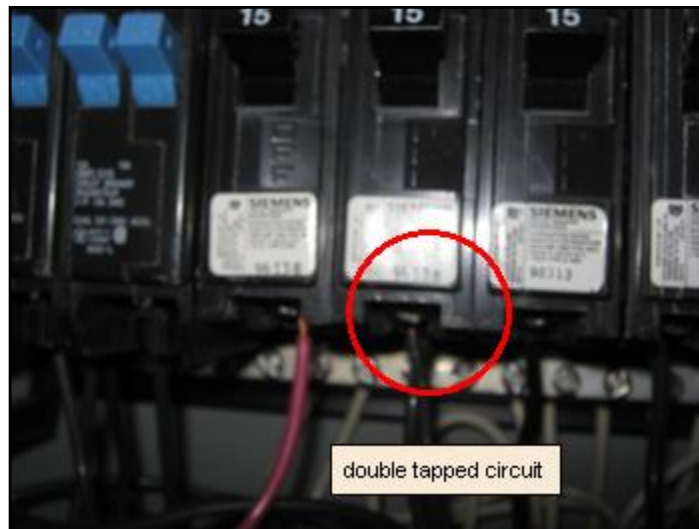
Condition: • [Double tap \(two wires on one breaker or fuse\)](#)

Task: Improve

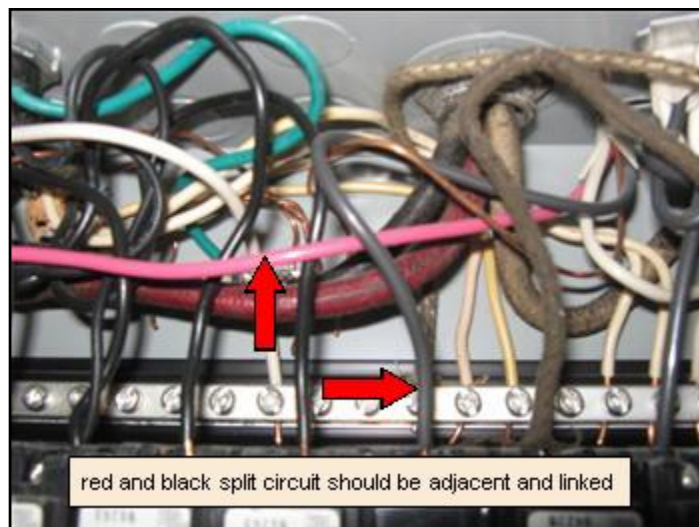
MAIN PANEL - WIRES \ 3.6, 3.9 & 3.11

Condition: • [Connections poor](#)

Task: Improve
