# Your Inspection Report

14 Herbert Ave  
Toronto, ON

**INSPECTION DATE:**  
Wednesday, February 24, 2010

Report No. 8840, v.4

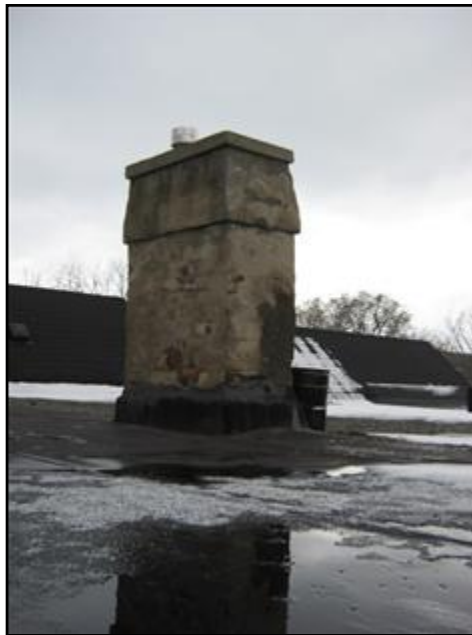
### **CHIMNEY(S) \ 3.0**

**Condition:** • Prior repairs

**Task:** Monitor

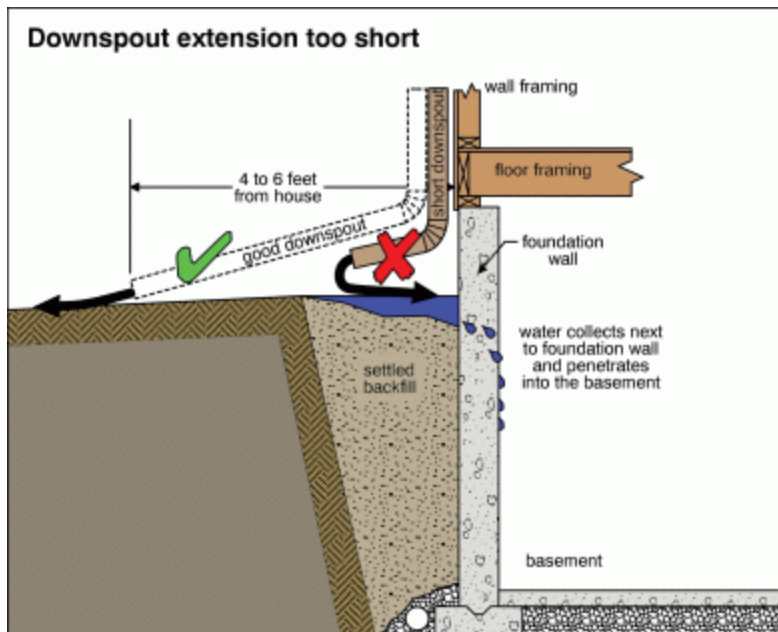
### DOWNSPOUTS \ 1.0

**Condition:** • [Downspout ends too close to home. It should direct water at least 6 feet from building.](#)

**Location:** Various Exterior

**Task:** Improve

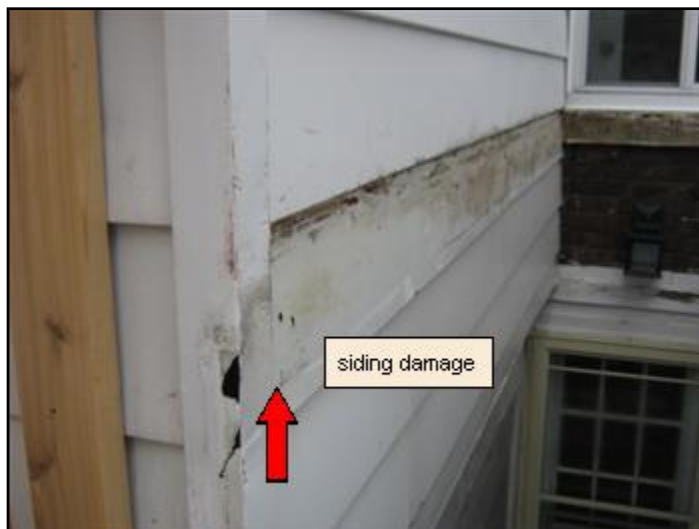
## WALL SURFACES \ 4.0

Condition: • [Damage](#)

Location: Rear Addition

Task: Repair

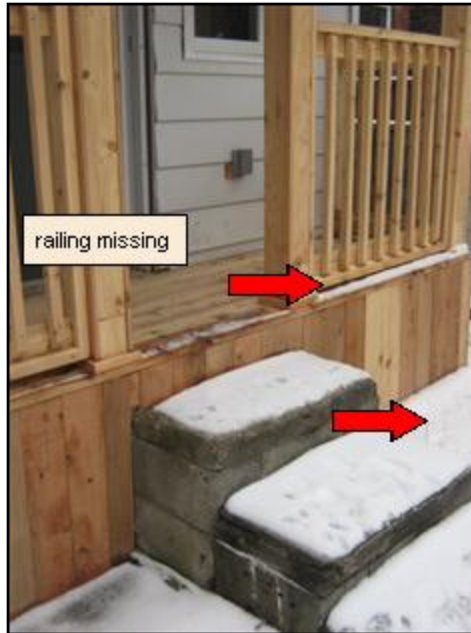
## EXTERIOR STRUCTURE \ Railings (5.2)

Condition: • [Missing](#)

Location: Rear Staircase

Task: Provide

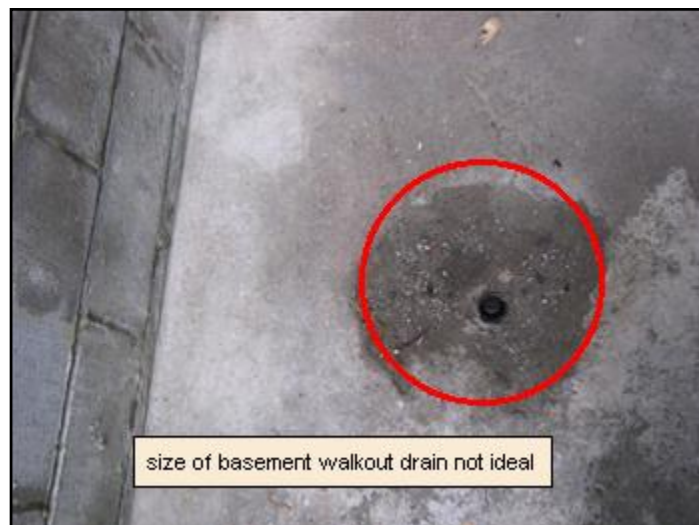
## **BASEMENT WALK-OUT \ 7.0**

**Condition:** • [Drain ineffective \(7.4\)](#)

**Location:** Basement

Size of drain may need to be increased depending on accumulation of water in this area.

**Task:** Improve

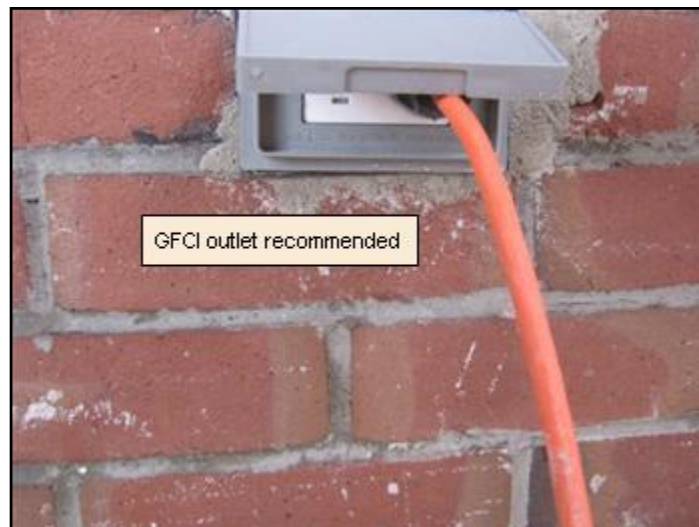
### GROUND FAULT CIRCUIT INTERRUPTERS \ 5.3.1

**Condition:** • [Missing](#)

**Location:** Front Porch

**Task:** Provide
