Your Inspection Report

172 Major St
Toronto, ON

Friday, February 12, 2010

Report No. 8752, v.3

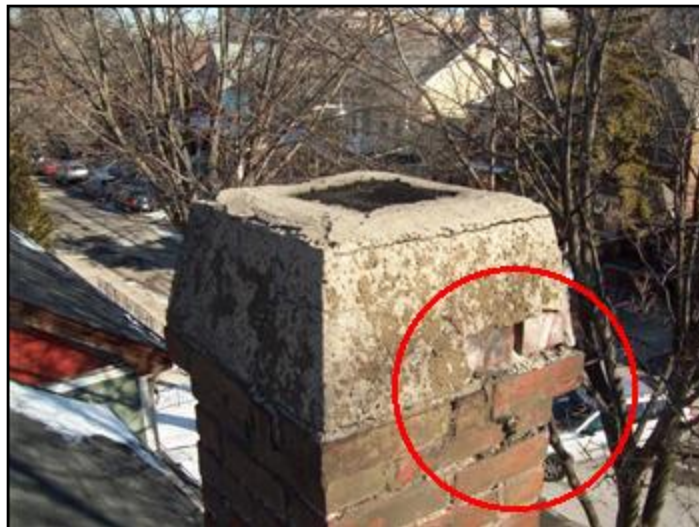
CHIMNEY(S) \ 3.0

Condition: • [Cap poor design \(3.1\)](#)

Condition: • [Mortar deteriorated/missing](#)

Task: Repair

Time: Less than 1 year

Cost: \$1,000 - \$2,000

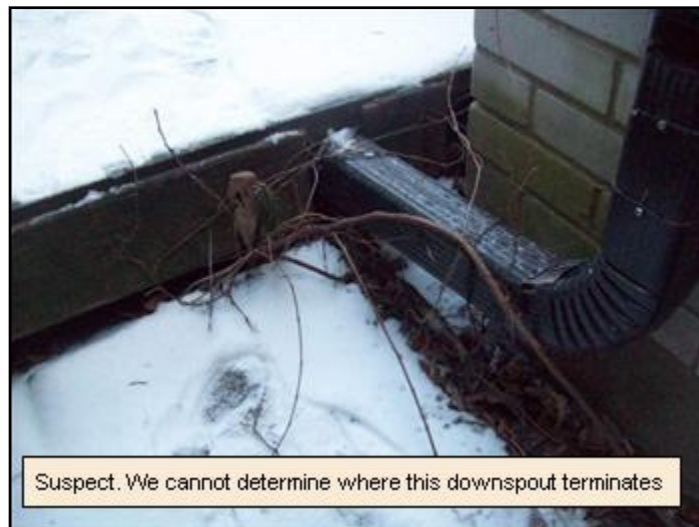
DOWNSPOUTS \ 1.0

Condition: • [Poor location - potential erosion](#)

Task: Repair

Time: Less than 1 year

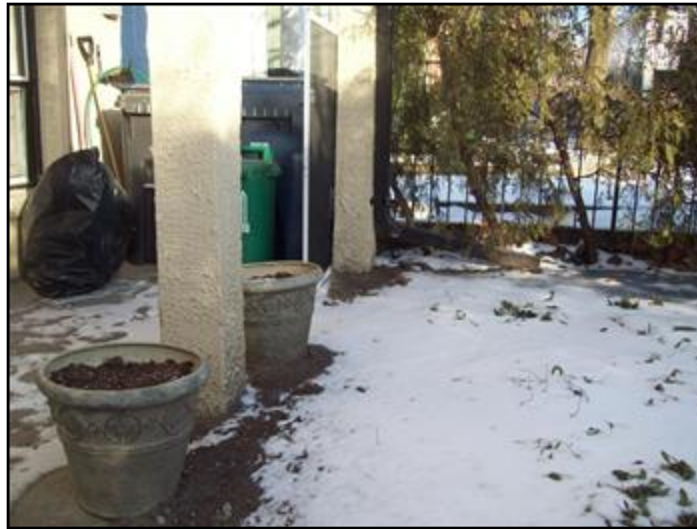
LOT GRADING \ (2.0 & 6.0)

Condition: • [Low areas](#)

slopes towards house

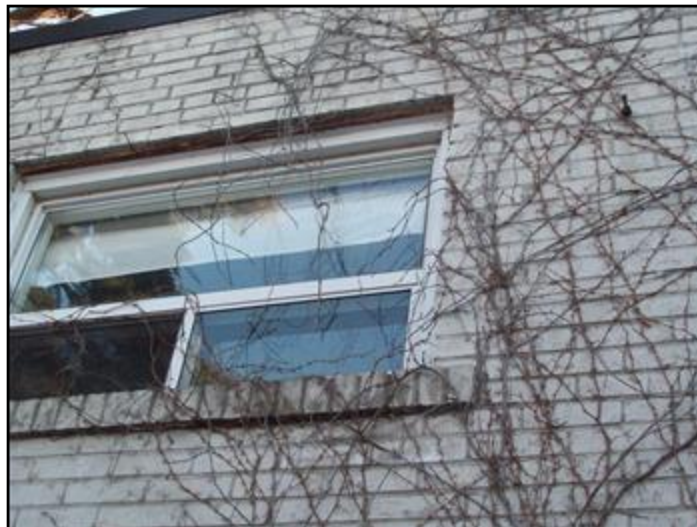
WALL SURFACES \ 4.0

Condition: • Vines may damage the home over time. If vines are to remain, and we understand the aesthetic reasons for leaving them, we recommend controlling the growth so vines do not attach to wood surfaces or roofs, and do not clog gutters and downspouts.

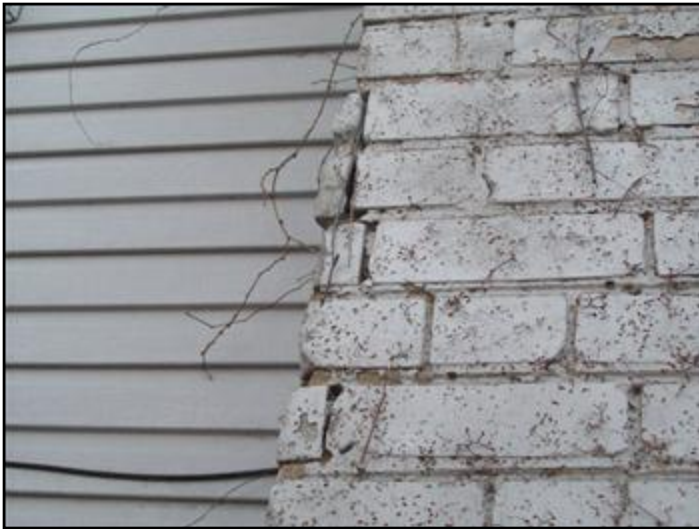
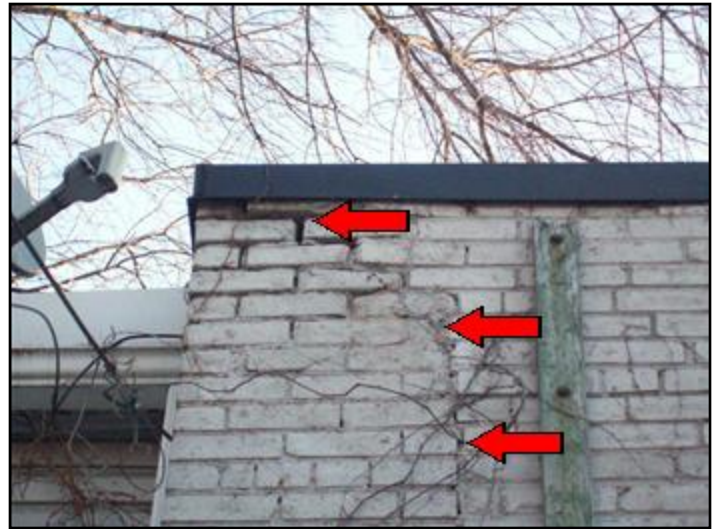
Condition: • [Deteriorated](#)

This should be repaired in the near future to avoid further deterioration.

Mortar Deterioration

Task: Repair

Time: Less than 1 year

Cost: \$1000 and up depending on approach

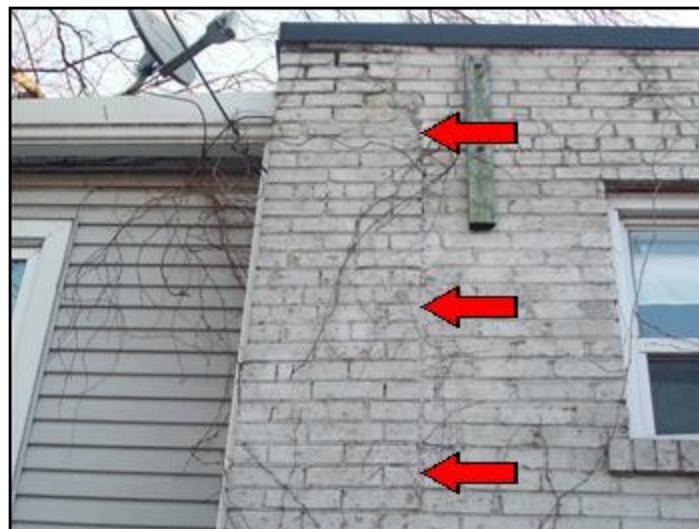
Mortar Deterioration in joints

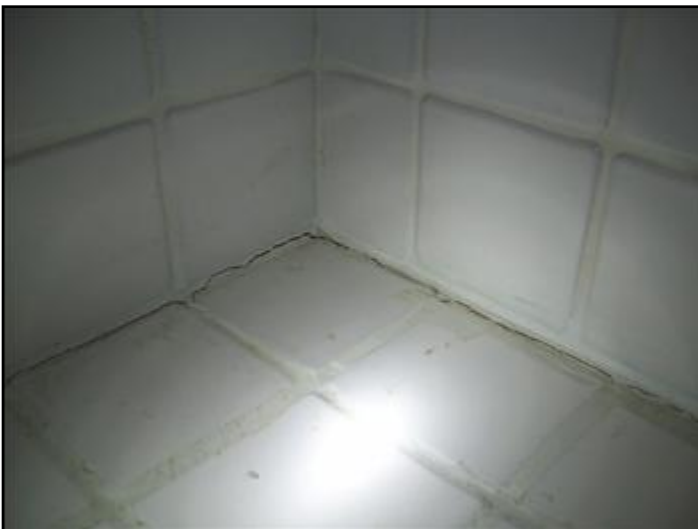
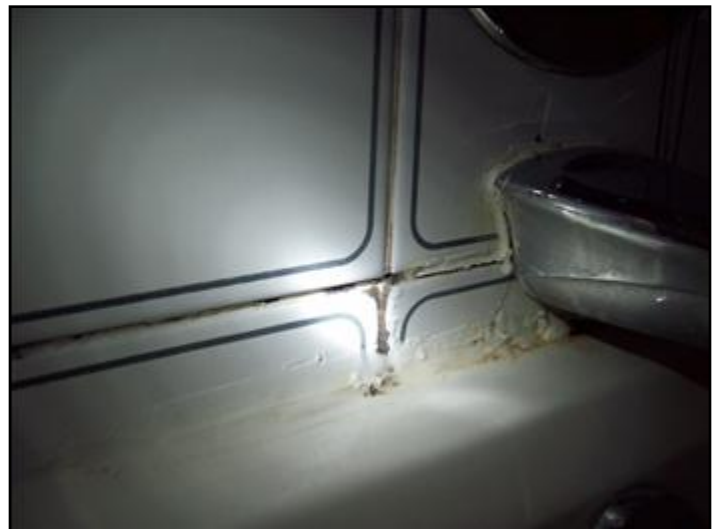
Deteriorating tile. Some mildew noted.

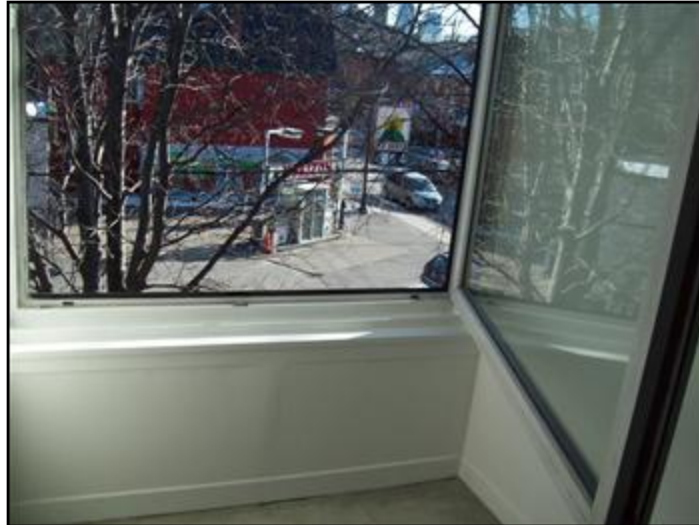
Caution. Second storey window. Fall hazard.

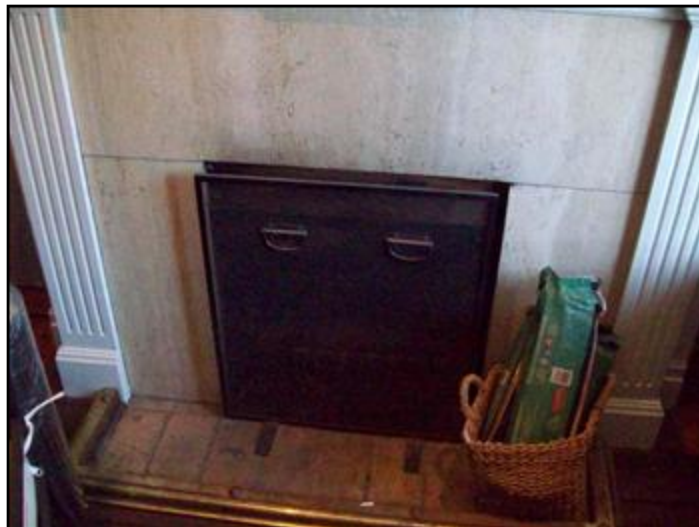
FIREPLACE OR WOOD STOVE \ 8.0

Condition: • Fireplace, flue and chimney should be inspected and swept as needed by a WETT certified technician and any recommended repairs completed before the fireplace is used. (WETT - Wood Energy Technology Transfer Inc. is a non-profit training and education association.) See www.wettinc.ca.

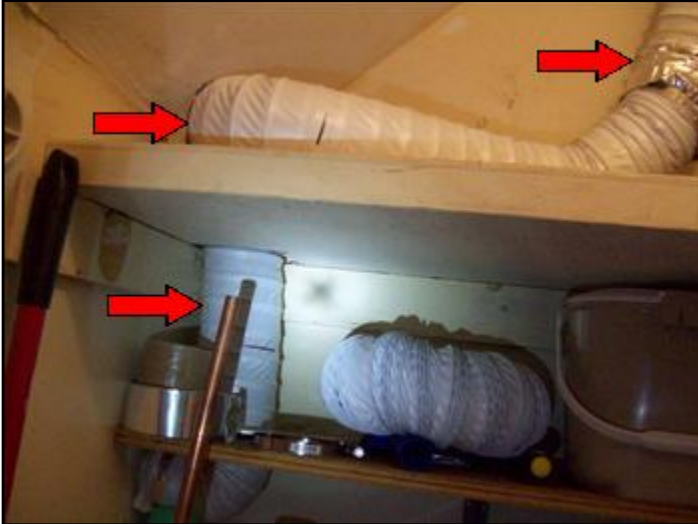
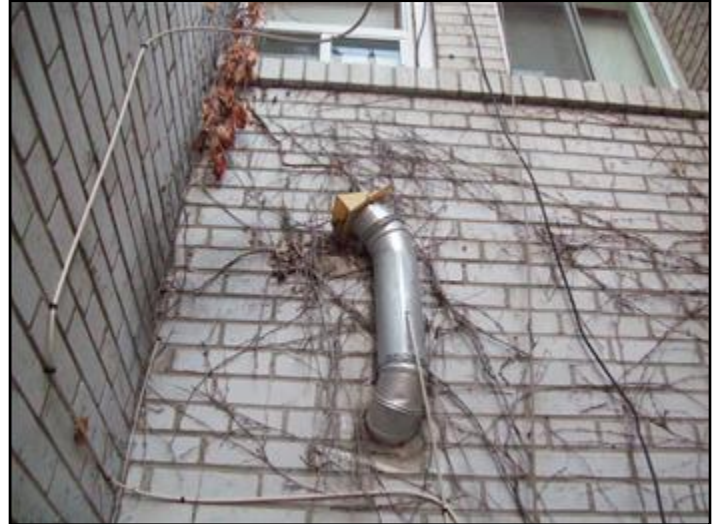
Condition: • Inappropriate Materials or Installation

Dryer vent

Task: Further evaluation

Time: Immediate
