Your Inspection Report

200 Manor Rd E
Toronto, ON

INSPECTION DATE:
Friday, March 26, 2010

RE: Report No. 9053, v.3
200 Manor Rd E
Toronto, ON

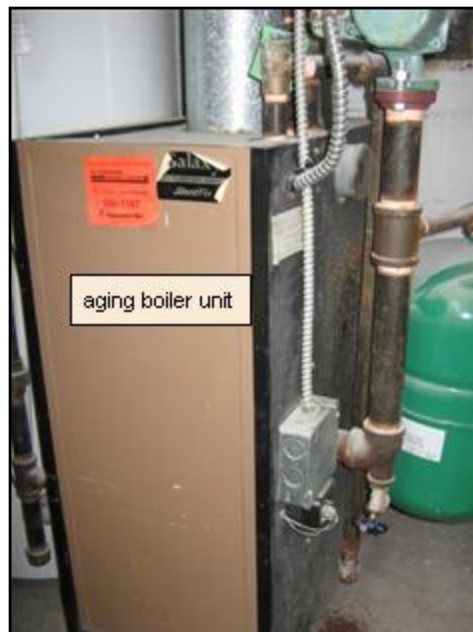
BOILER \ 13.0

Condition: • Near end of normal life expectancy

Task: Replace

Time: Unpredictable

Cost: \$3,500 and up

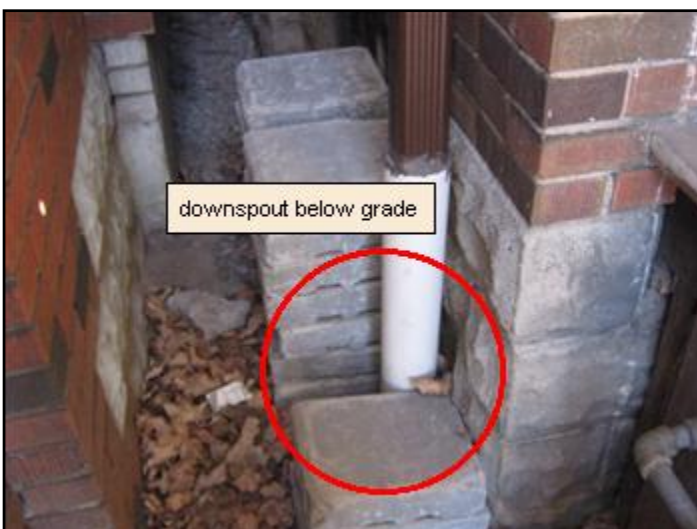
front

DOWNSPOUTS \ 1.0

Condition: • The City of Toronto requires downspouts be disconnected from the city sewers. Why? The sewers handle both storm water and waste from houses. Waste has to go through the sewage treatment system, which is very expensive. Storm water does not have to be treated, and should not go into city sewers. Downspouts should discharge above grade onto the lawn at least 6 feet from the home. This may require relocating downspouts and re-sloping gutters.

Task: Improve

Time: Less than 1 year

Cost: Minor

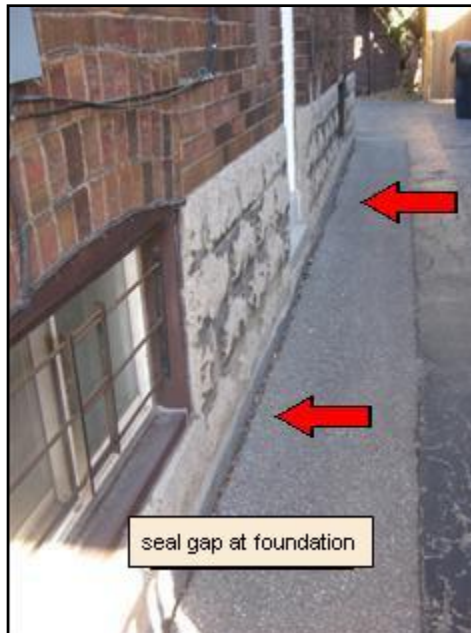
right side

DRIVEWAYS \ 6.0

Condition: • Seal gap at house

Task: Improve

Time: Less than 1 year

Cost: Minor

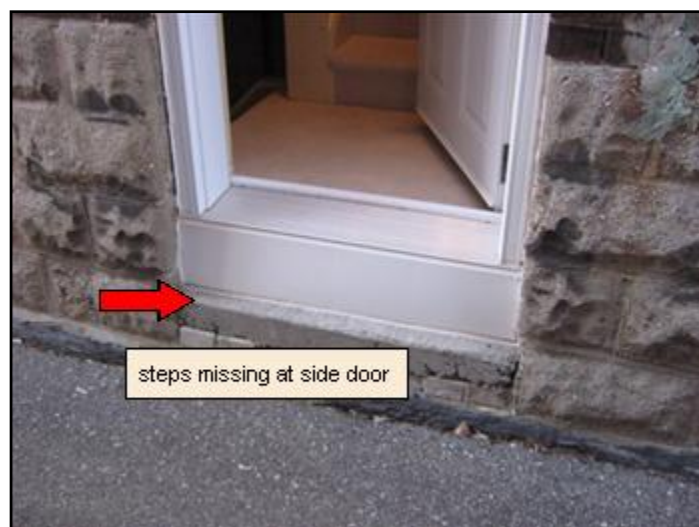
side door

EXTERIOR STRUCTURE \ Steps (5.1)

Condition: • Missing Step

Task: Provide

Time: Discretionary

Cost: Minor

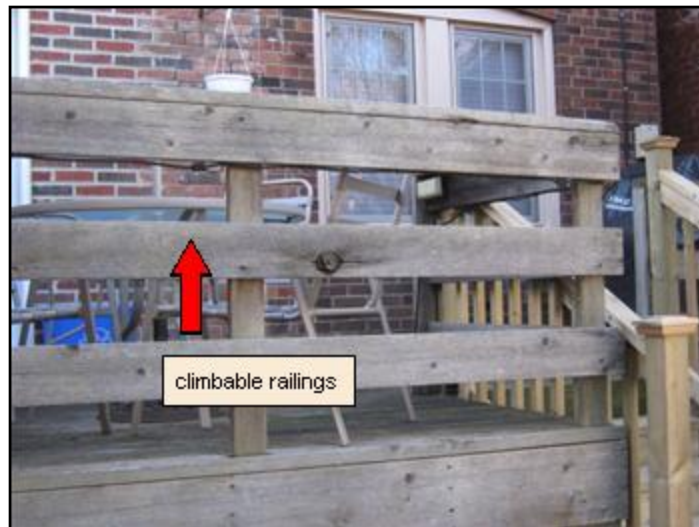
deck

EXTERIOR STRUCTURE \ Railings (5.2)

Condition: • Climbable

Task: Improve

Time: Discretionary

Cost: Minor

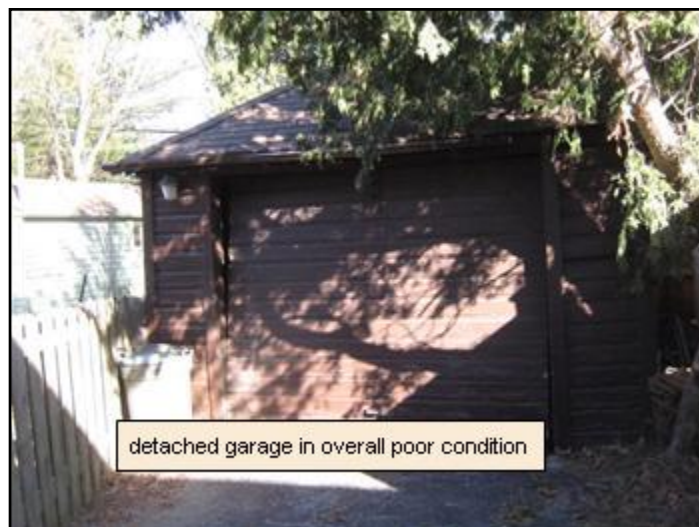
GARAGE \ 8.0

Condition: • Disrepair (8.1)

Task: Monitor/Repair or replace

Time: If necessary

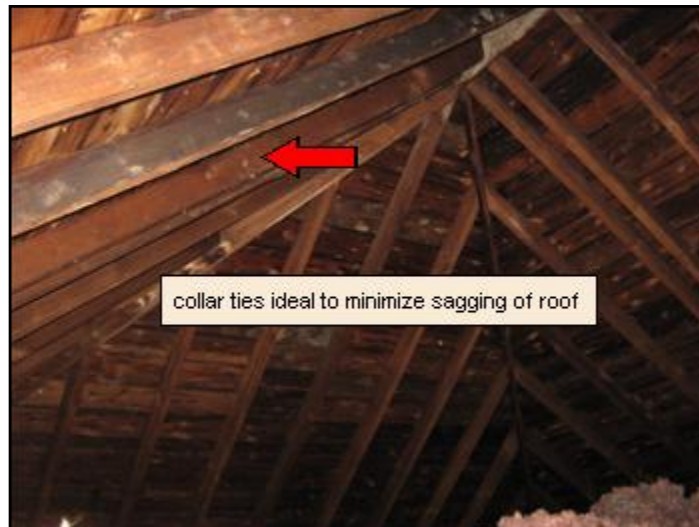
attic

Condition: • Collar ties missing (7.2)
currently no signs of roof sag

Time: If necessary

Cost: Minor

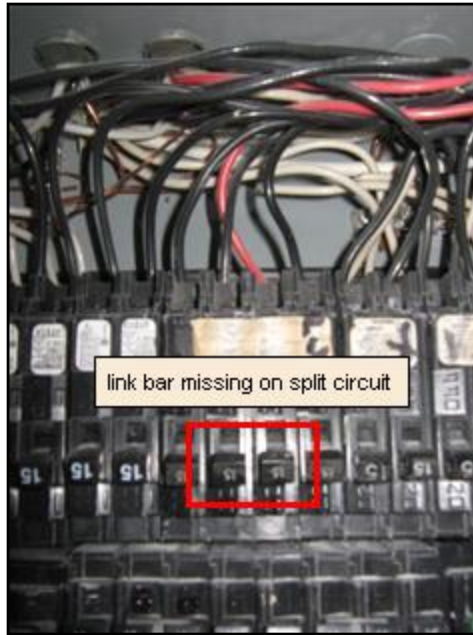
main panel

Condition: • Link missing on multiwire circuit

Task: Provide

Cost: Minor

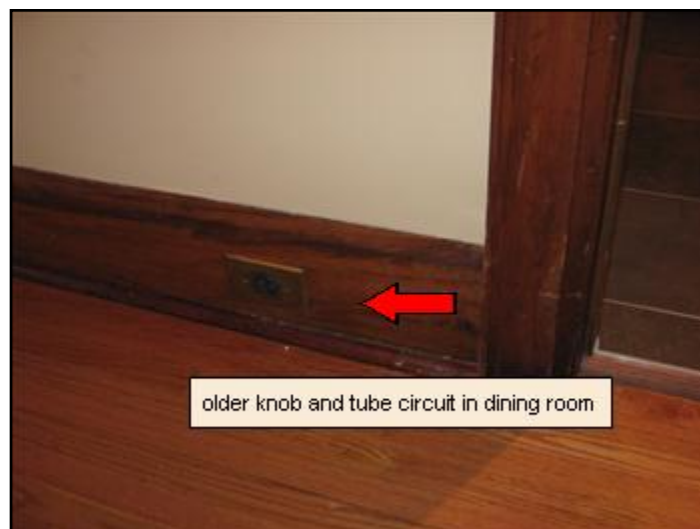
dining room

HOUSE WIRING - KNOB-AND-TUBE \ 4.4

Condition: • Knob-and-tube wiring was noted in the home.

This was the only circuit noted

Task: Remove

Cost: Minor

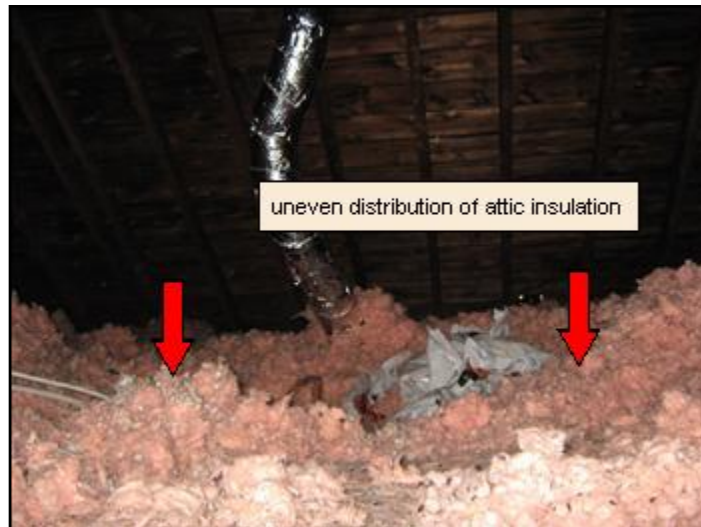
attic

Condition: • Insulation uneven

Time: Less than 1 year

Cost: Minor
