Your Inspection Report

27 Dearbourne Ave
Toronto, ON

INSPECTION DATE:
Friday, June 4, 2010

RE: Report No. 9722, v.3
27 Dearbourne Ave
Toronto, ON

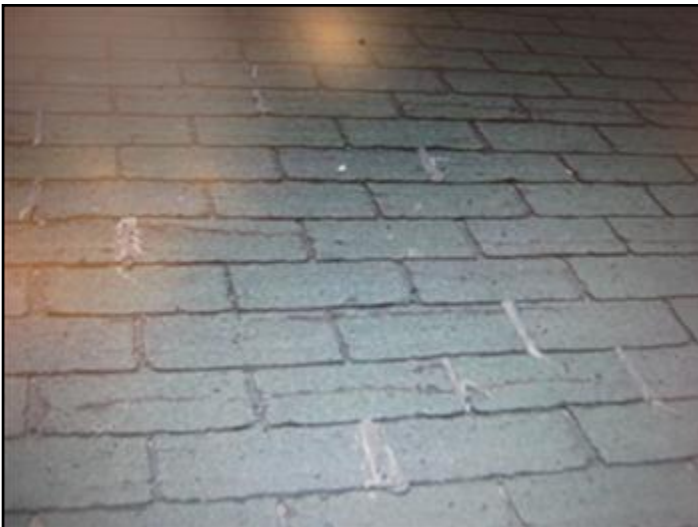
rear sloped roof

SLOPED ROOF(S) \ 1.0

Condition: • Near end of normal life expectancy

Location: Throughout

Task: Replace

Cost: \$4,000 and up

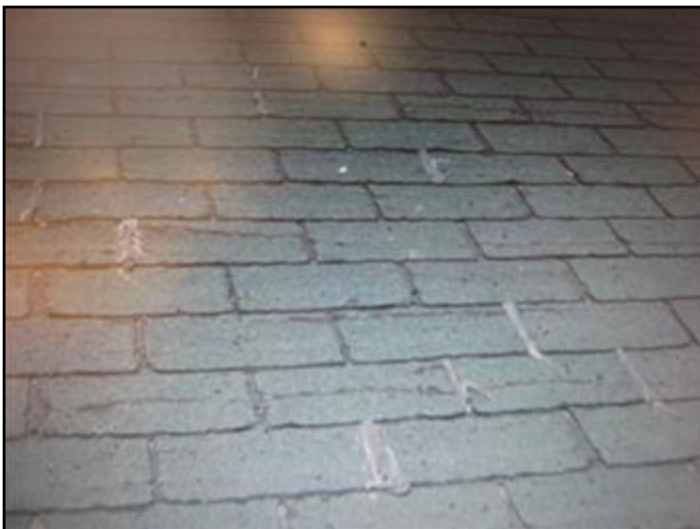
rear sloped roof

SLOPED ROOF(S) \ 1.0

Condition: • Near end of normal life expectancy

Location: Throughout

Task: Replace

Cost: \$4,000 and up

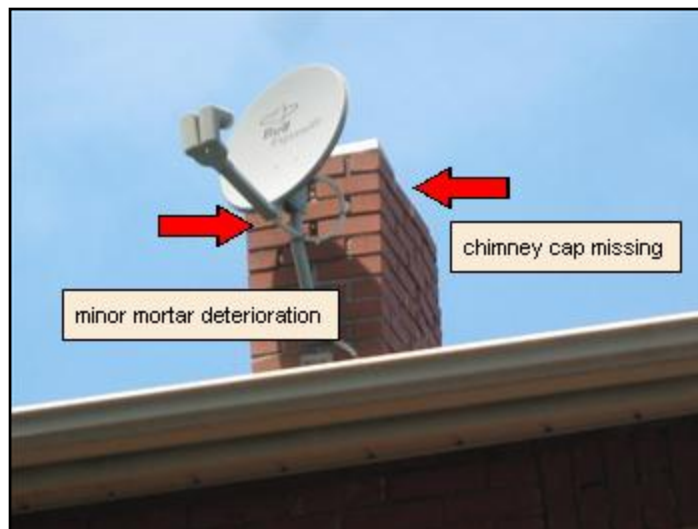
masonry chimney

CHIMNEY(S) \ 3.0

Condition: • Cap deteriorated/missing (3.1)

Task: Provide

Time: When replacing roof

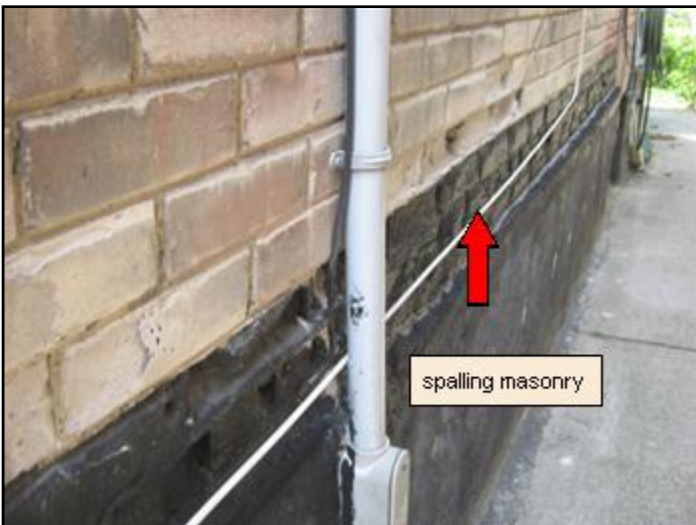
side wall

WALL SURFACES \ 4.0

Condition: • Mortar or masonry deterioration

Spalling and deterioration typical of improper removal of cement parging. Seeking expertise of Mason for improvement recommendations.

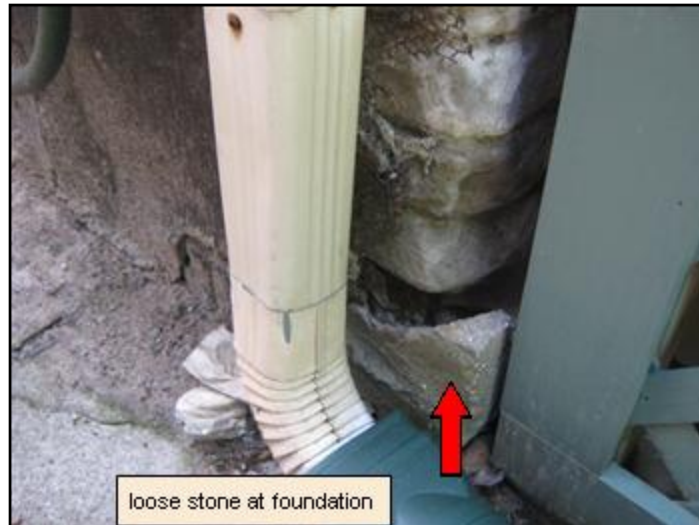
front corner

FOUNDATION WALLS \ 4.18

Condition: • Loose stone

Location: Front

Task: Repair

Time: Less than 1 year

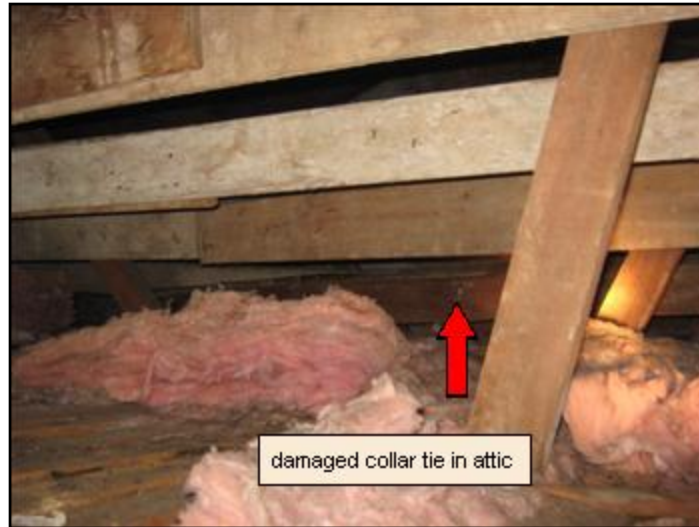
attic space

Condition: • Collar ties damage (7.2)

Task: Repair or replace

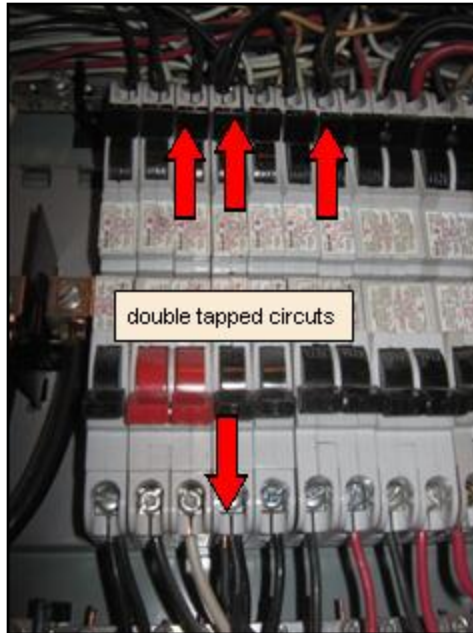
main service panel

Condition: • Double tap (two wires on one breaker or fuse)

Task: Improve

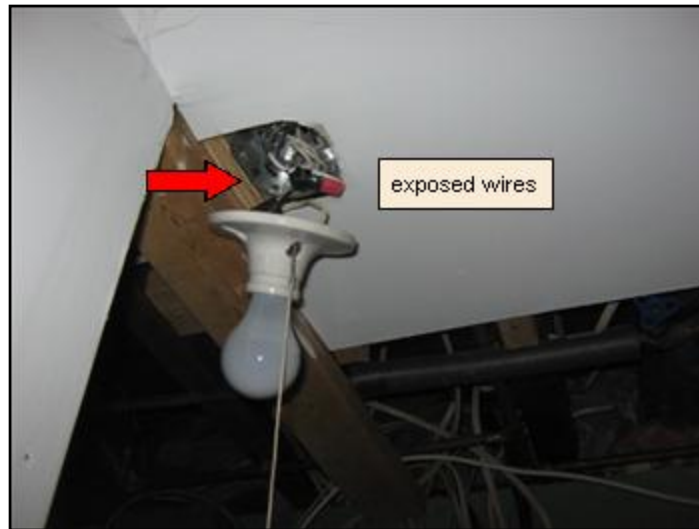
basement

Condition: • Exposed wires

Task: Improve

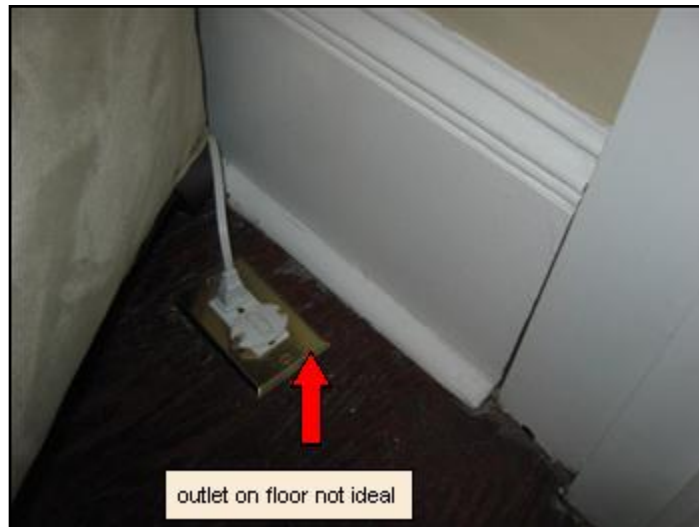
living room

OUTLETS \ 5.2

Condition: • Location poor

Task: Remove

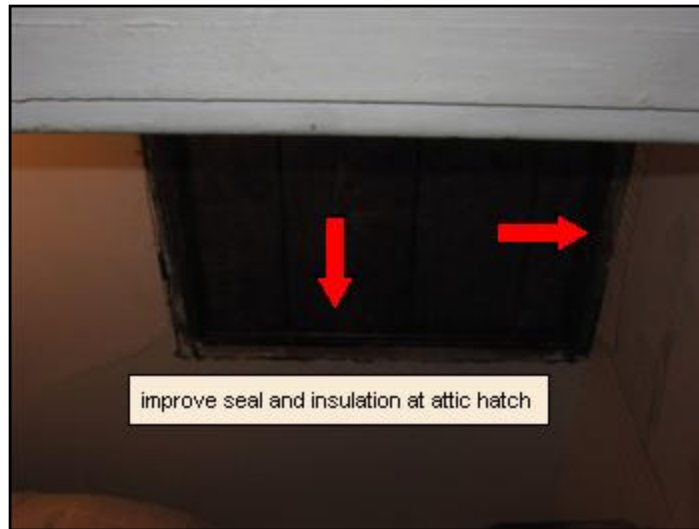
Condition: • Ventilation obstructed

Location: Front Attic

Time: Less than 1 year

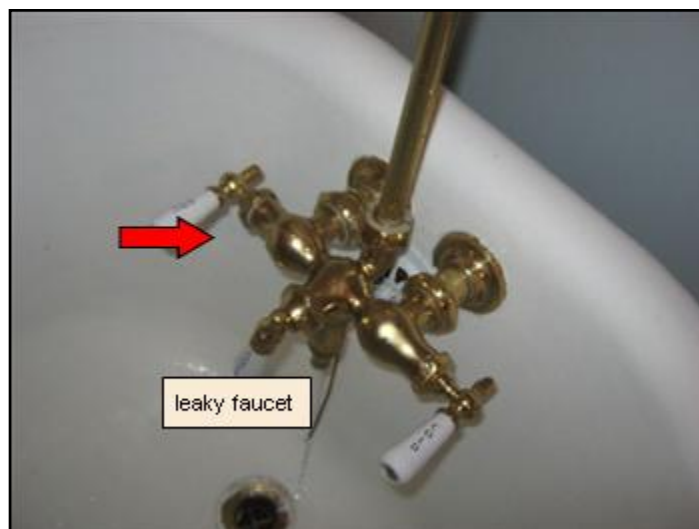
2nd floor bath

Condition: • Leak

Task: Repair

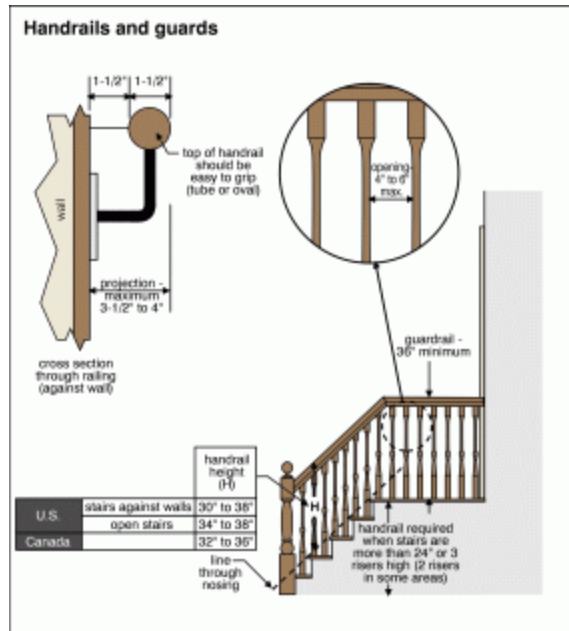
Condition: • Railing missing

Time: Discretionary
