# Your Inspection Report

38 McNairn Ave  
Toronto, ON

**INSPECTION DATE:**  
Monday, April 19, 2010

Report No. 9298, v.2  
For inspection at:  
38 McNairn Ave  
Toronto, ON

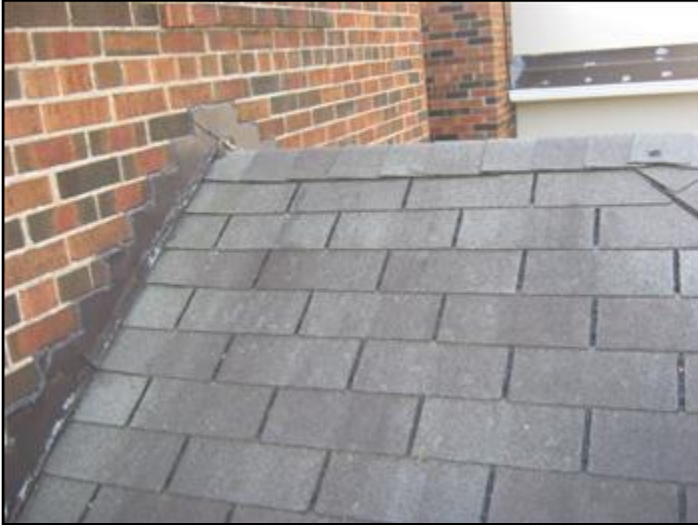
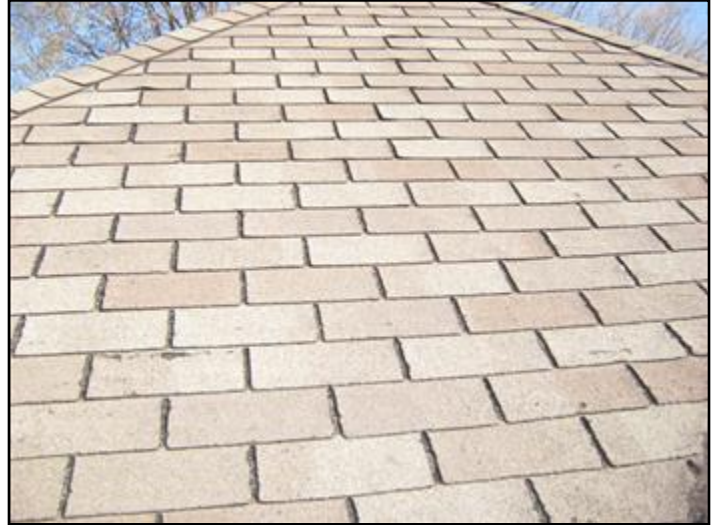
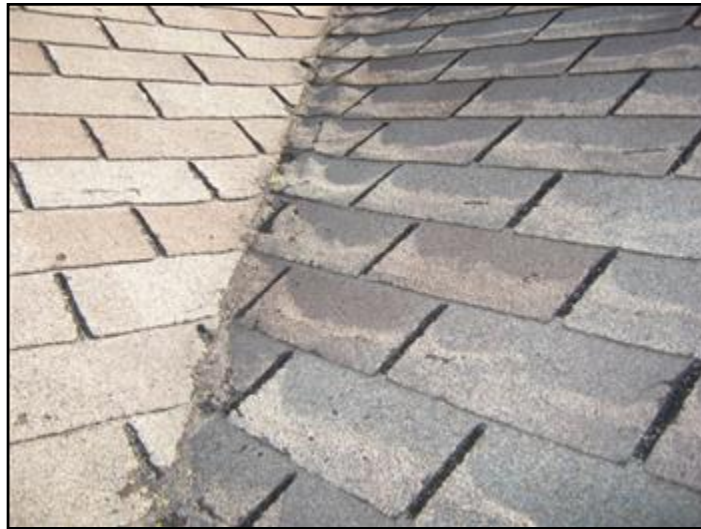
**Life Expectancy:** • The roof covering appears to be within the last half of its life.

**Condition:** • [Split or tear](#)

overlapping valleys should be replaced with metal flashings when reroofing

**Task:** Monitor/Replace

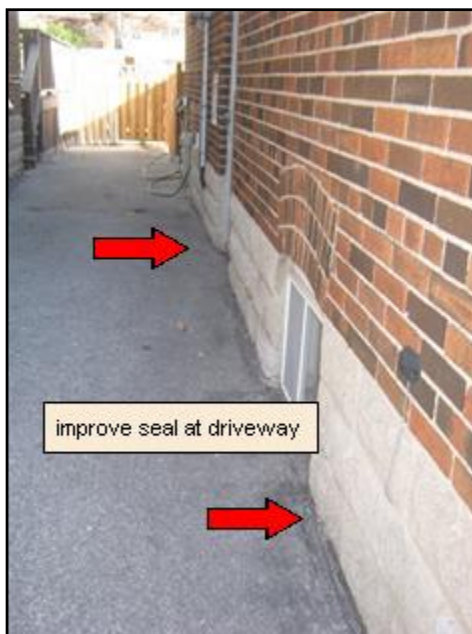
driveway

**Condition:** • [Seal gap at house](#)

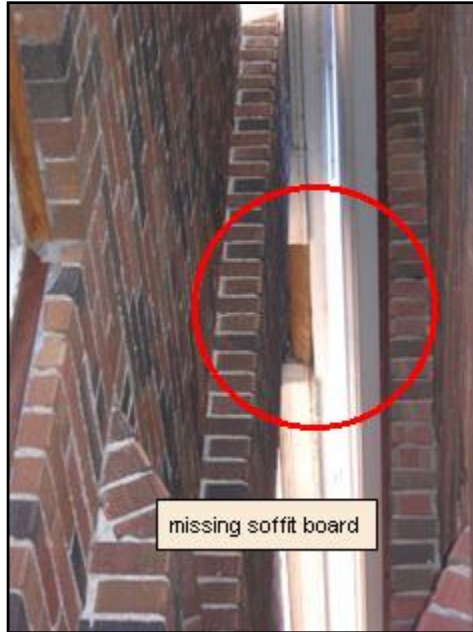
*east wall*

**Condition:** • [Damage](#)

**Task:** Repair

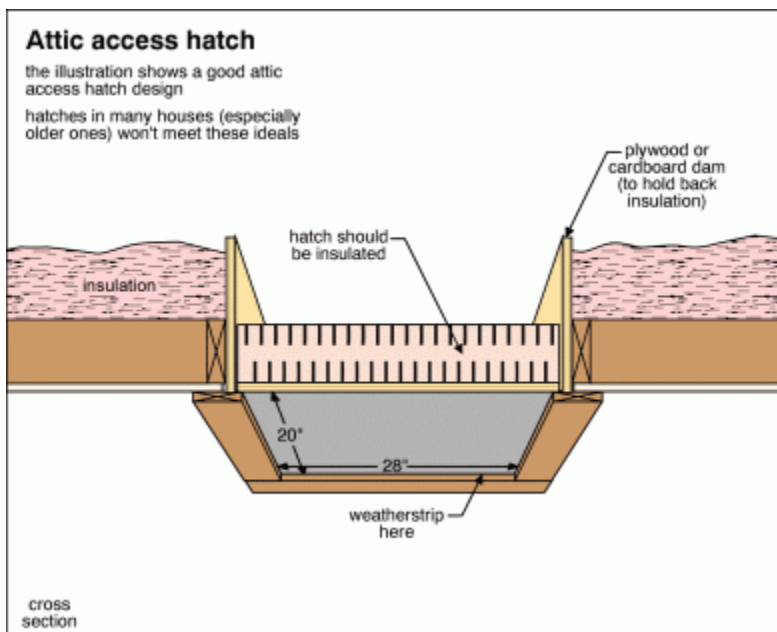
**Condition:** • Access hatch insulation/weatherstripping/fit less than ideal
