Your Inspection Report

3 Fordover Dr.
Toronto, ON

RE: Report No. 8896, v.2
3 Fordover Dr.
Toronto, ON
m1e1t7

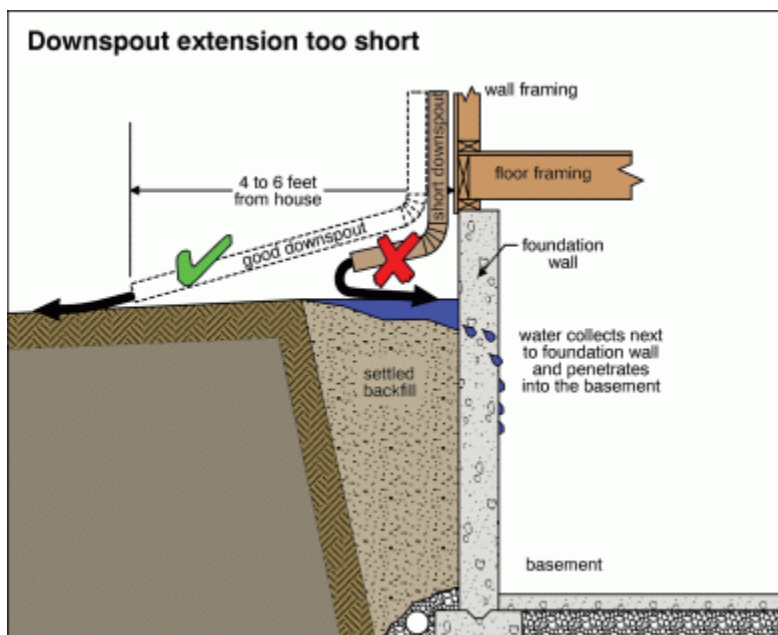
Condition: • [Downspout ends too close to home. It should direct water at least 6 feet from building.](#)

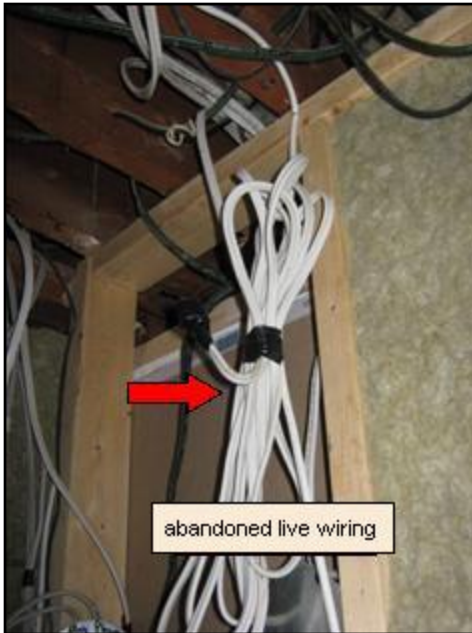
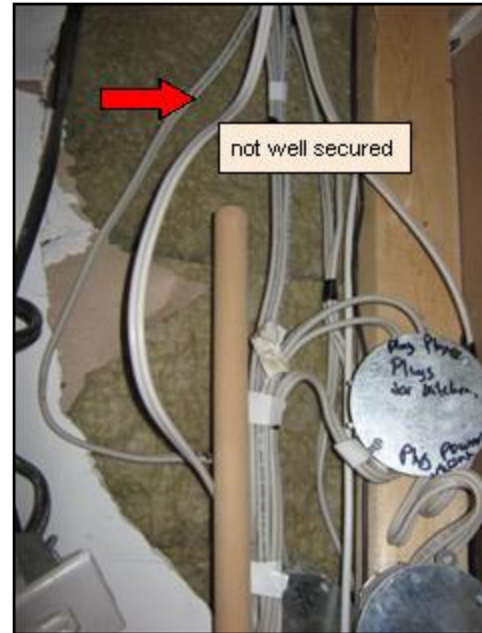
furnace room

Condition: • [Abandoned](#)

Condition: • [Not well secured](#)

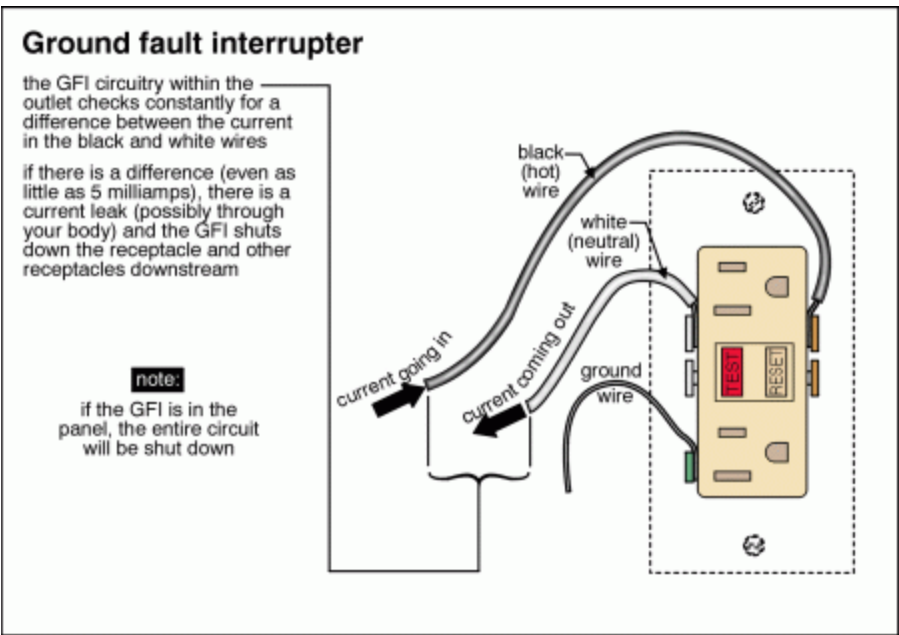
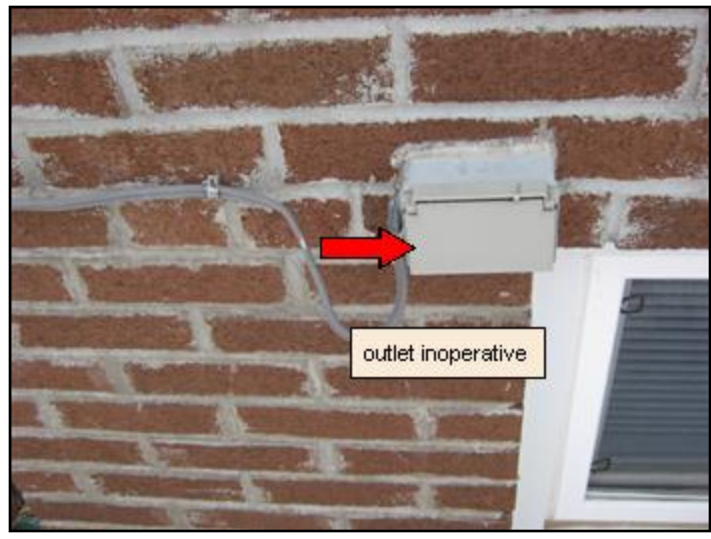
rear

Condition: • [Test faulty](#)

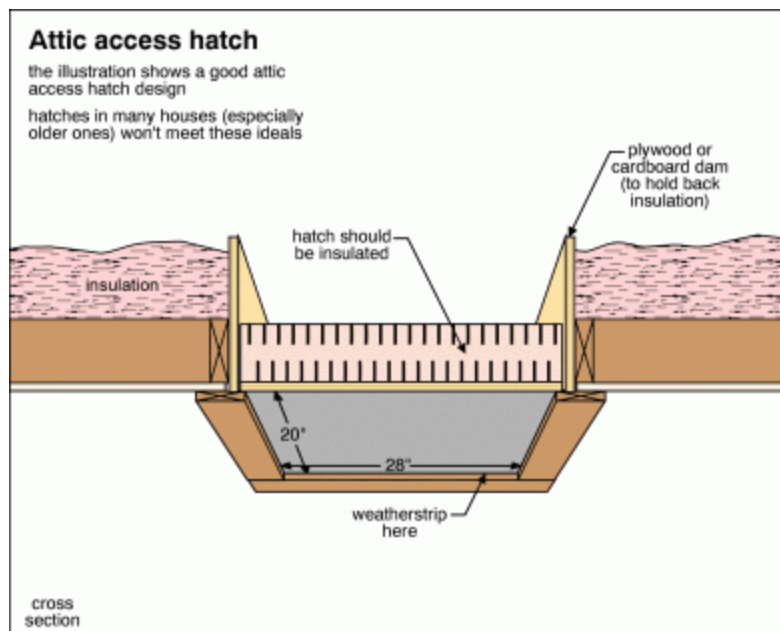
Condition: • Access hatch insulation/weatherstripping/fit less than ideal

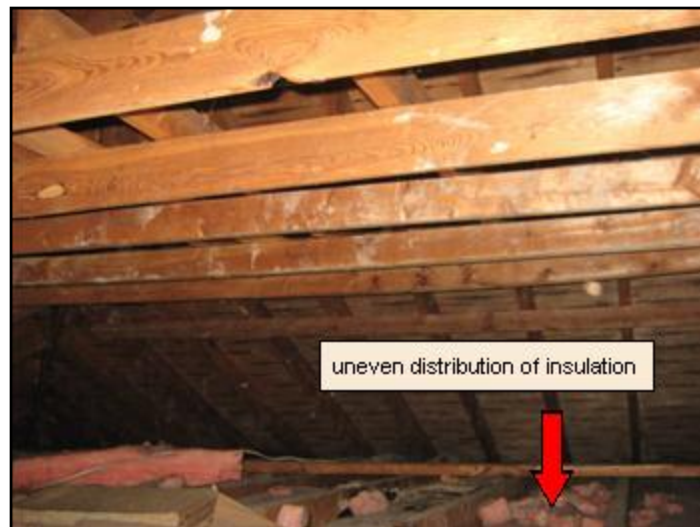
Condition: • [Insulation uneven](#)

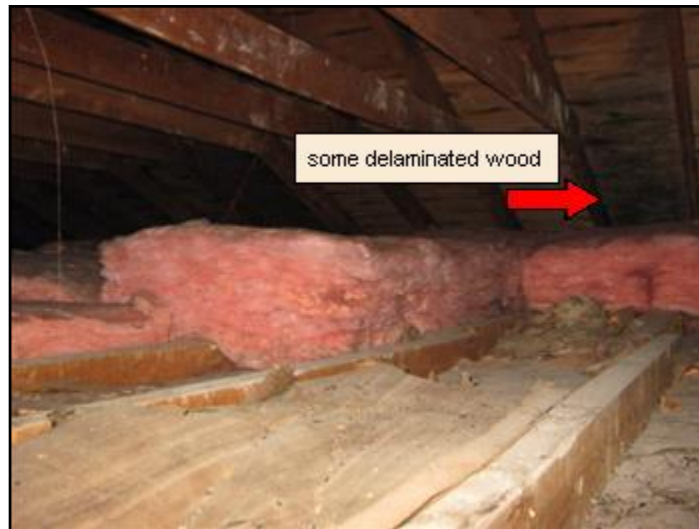
Condition: • [Ventilation obstructed at soffits](#)

Condition: • [Ventilation suspect](#)

Some delaminating of wood sheathing noted. This is due to poor ventilation. We recommend adding roof vents, clearing soffit vent areas, and sealing hatch to minimize moisture movement into attic space.

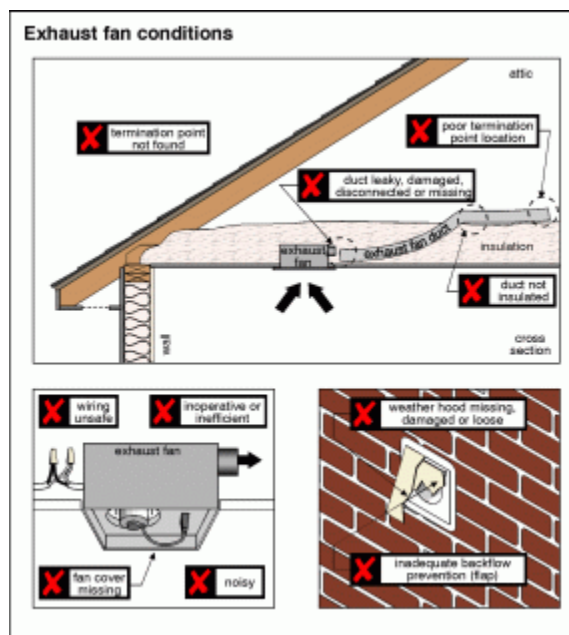
Condition: • [Discharge should be to exterior](#)
