Your Inspection Report

936 Carlaw Ave
Toronto, ON

INSPECTION DATE:
Friday, March 19, 2010

Report No. 8979, v.2

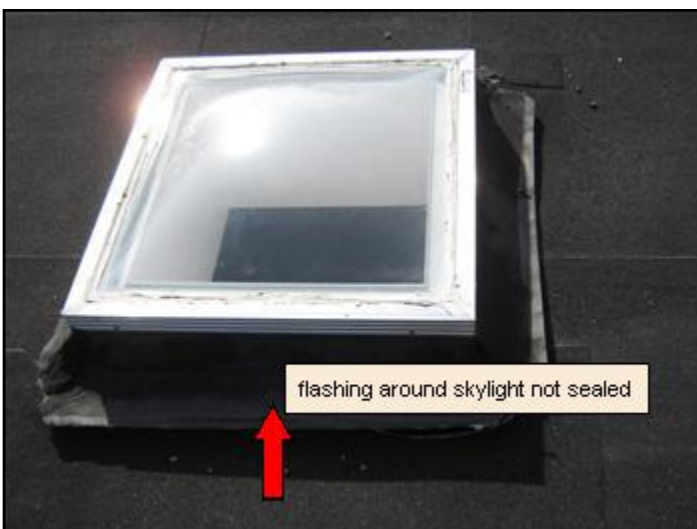
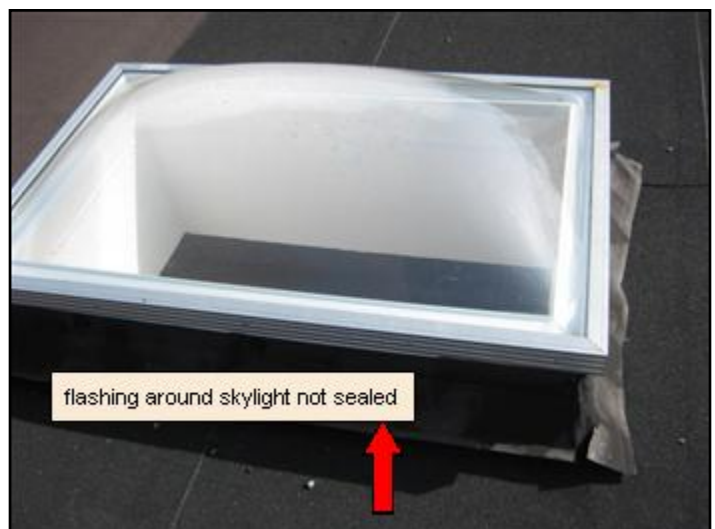
upper flat

FLASHINGS - SKYLIGHT \ 2.9

Condition: • [Caulking deteriorated/missing](#)

Location: Roof

Task: Provide

Time: Less than 1 year

Cost: Minor

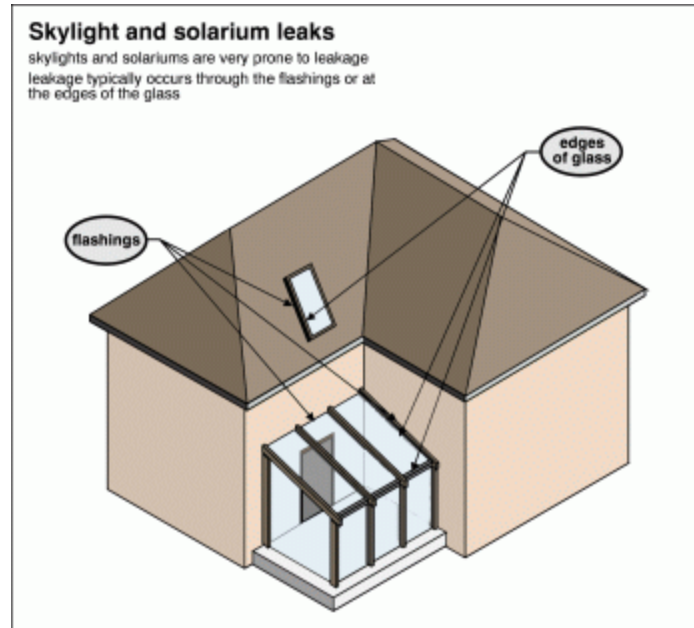
VULNERABLE AREAS \ 1.13, 1.14 & 1.15

Condition: • [Skylights are vulnerable areas for roof leaks](#)

Task: Monitor

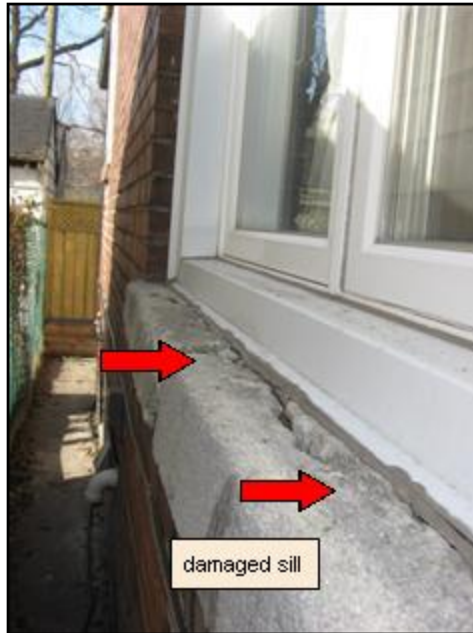
dining room window

WINDOWS - EXTERIOR SIDE \ 3.0

Condition: • [Sill damage](#)

Location: Exterior Wall

Task: Repair or replace

Time: Less than 2 years

Cost: Depends on approach

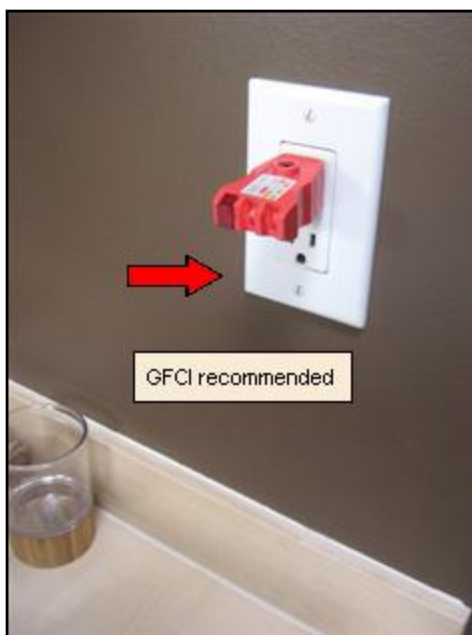
2nd floor bath

GROUND FAULT CIRCUIT INTERRUPTERS \ 5.3.1

Condition: • Adding Ground Fault Interrupters (GFIs) is a cost effective safety improvement to existing homes. At a cost of roughly \$100 each, installed, they provide enhanced protection against electric shock and are particularly useful near wet areas (e.g. outdoors, garages, kitchens - especially near the sink, bathrooms) and where appliances with 3-prong plugs are used. GFIs may be either special circuit breakers or special wall outlets (receptacles). Either one protects all downstream outlets on that circuit. (5.2.2)

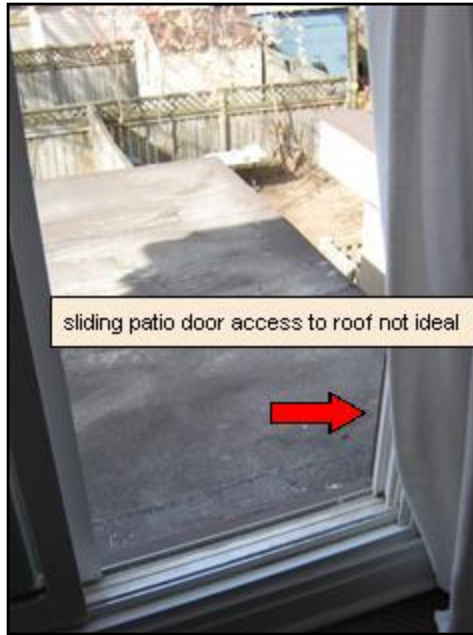
2nd floor bedroom

Condition: • Unsafe door - ideally there should be a deck with railings

Cost: Depends on approach

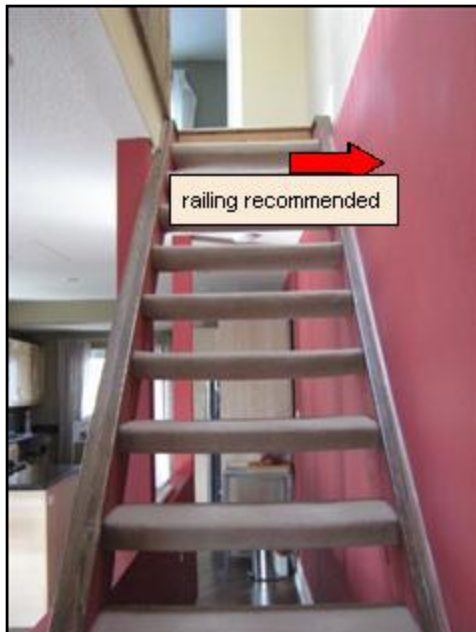
2nd floor

STAIRS \ 5.0

Condition: • [Railing missing](#)

Time: Less than 1 year

Cost: Minor
