# Your Inspection Report

14 Herbert Ave  
Toronto, ON

**INSPECTION DATE:**  
Wednesday, February 24, 2010

Report No. 8840, v.4

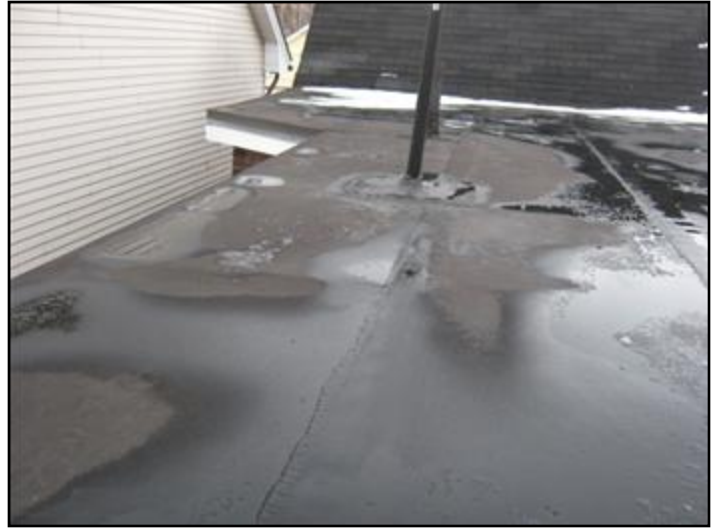
*upper roof*

**Life Expectancy:** • The roof covering is not expected to require replacement in the short term, although some maintenance may be required.
